Buckeye Lake Dam

Fairfield and Licking Counties, Ohio

REVIEW OF PAST REPORTS AND EXISTING CONDITIONS AND RECOMMENDATIONS FOR INTERIM RISK REDUCTION MEASURES, OPERATION, AND MAINTENANCE

March 2015

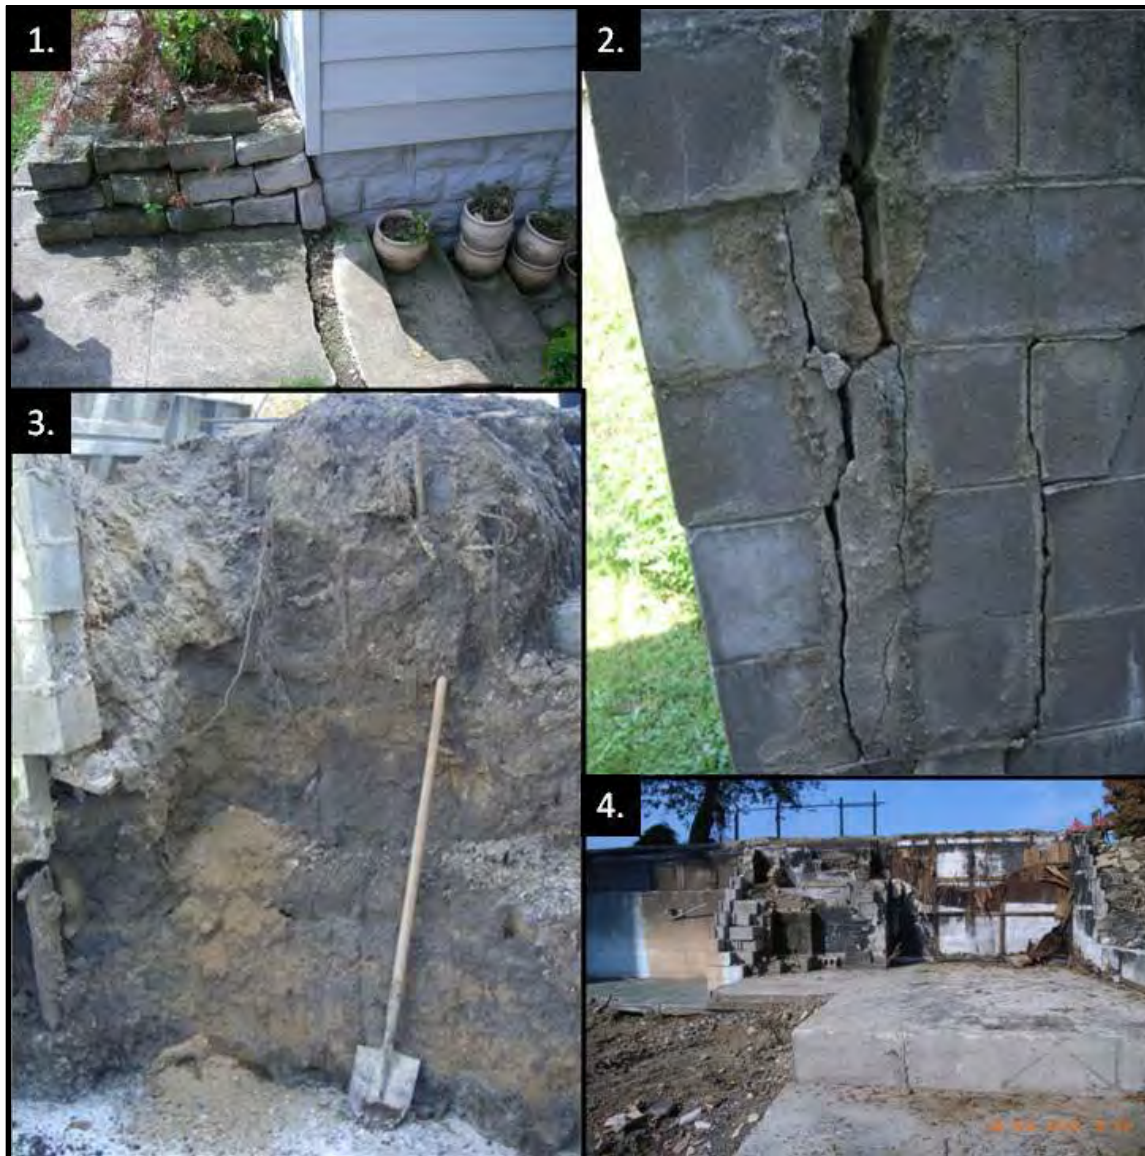
Figure 1. Typical Embankment Distress Observations 1) Differential settlement of structure built into crest/embankment longitudinal cracking 2) Failing masonry unit wall supporting landside embankment materials 3) Unsupported excavation into downstream face of embankment which could cause weakening of embankment soils and embankment failure 4) Several rows of masonry unit walls were noted in old house foundations likely indicating seepage related displacement

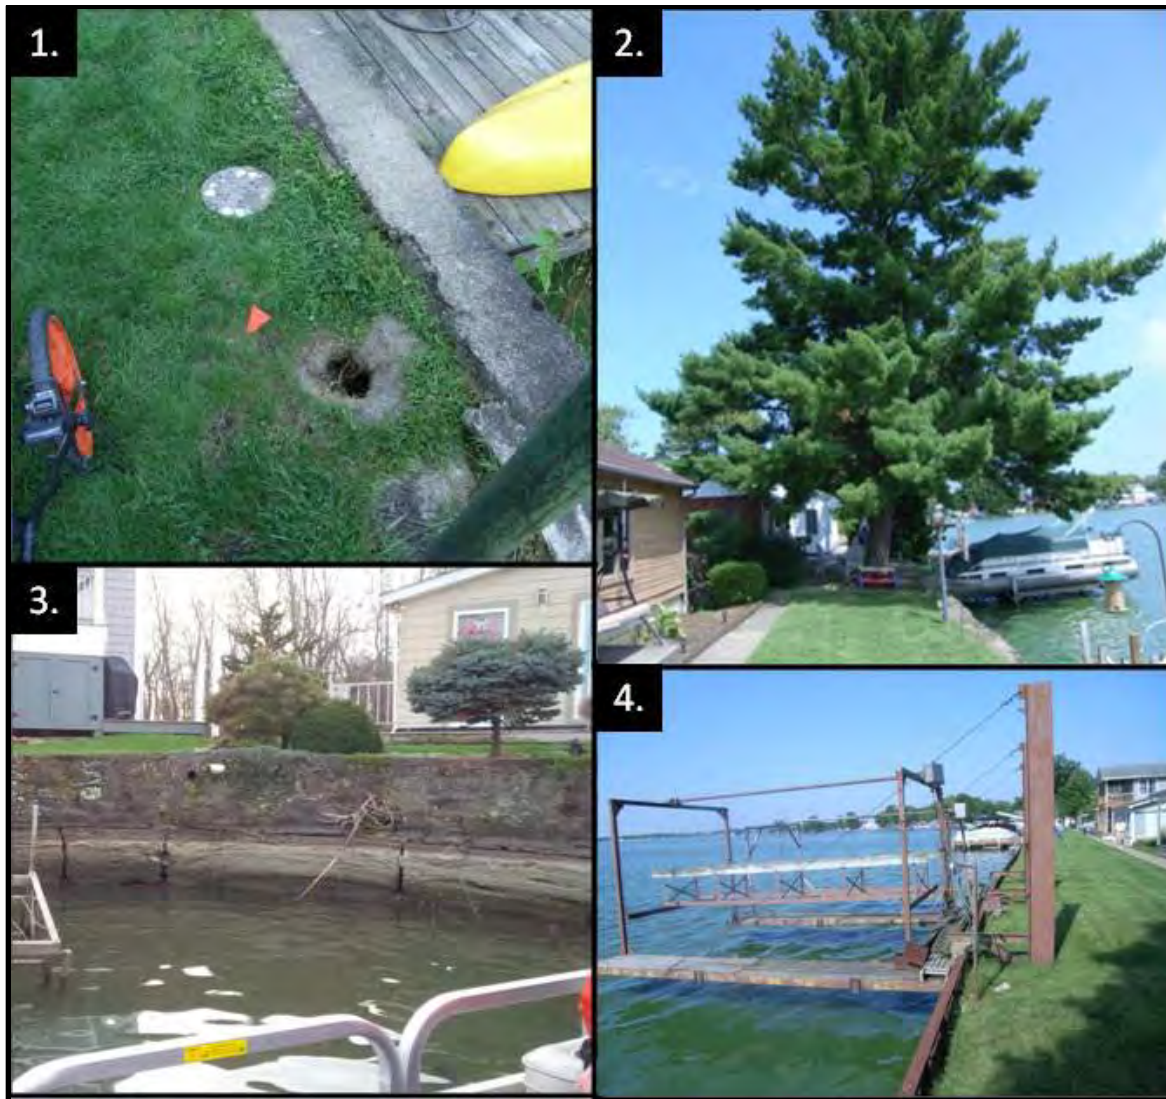
Figure 2. Typical Distress Observations 1) One of many depressions behind masonry wall 2) Tree with root system spanning the entire embankment crest 3) Numerous cracks within base of, and pipe/utility penetrations through, masonry wall observed during winter pool drawdown 4) Dock structures cantilevering from the dam put stress on the sheetpiling for which it was not designed

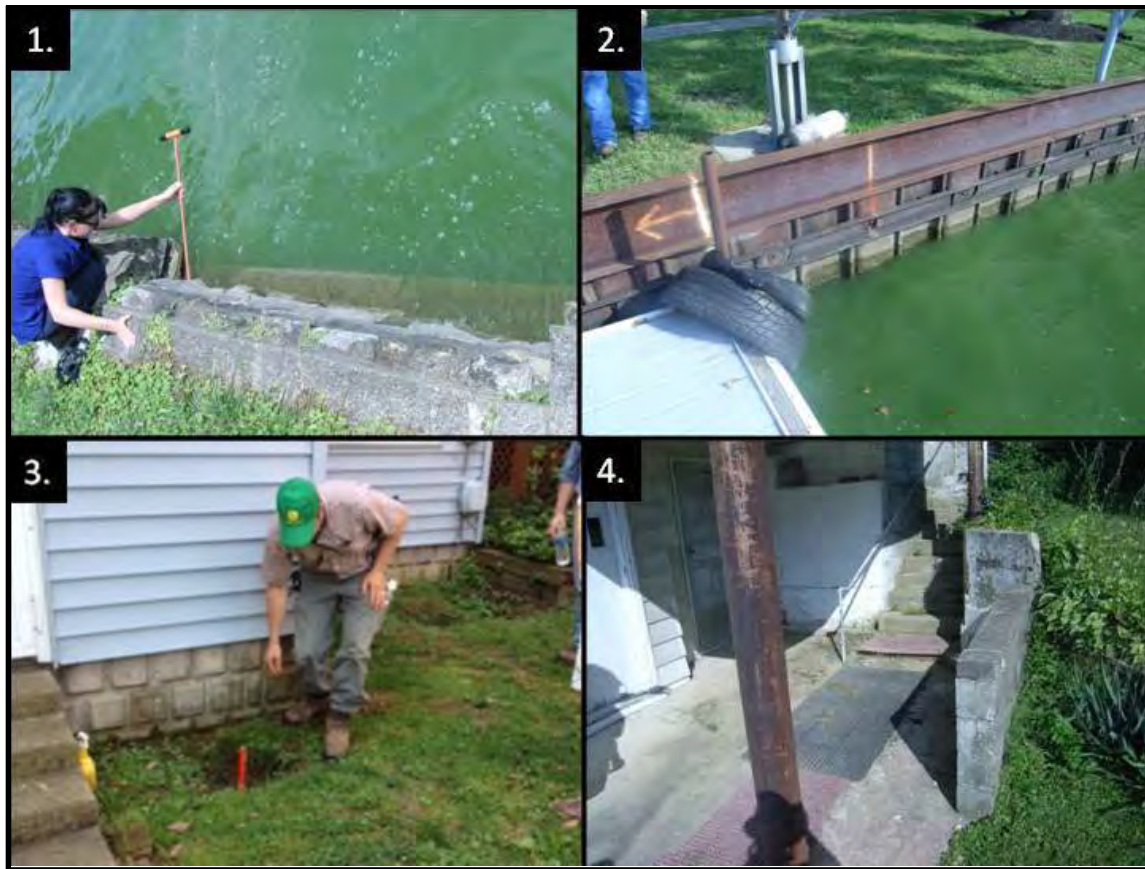
Figure 3. Other Wall and Seepage Observations 1) Displaced portion of masonry wall 2) Numerous rust holes observed in sheetpiling 3) Several depressions possibly due to boils, together with very shallow ground water conditions, were observed 4) Location of persistent seepage near Black Diamond Point

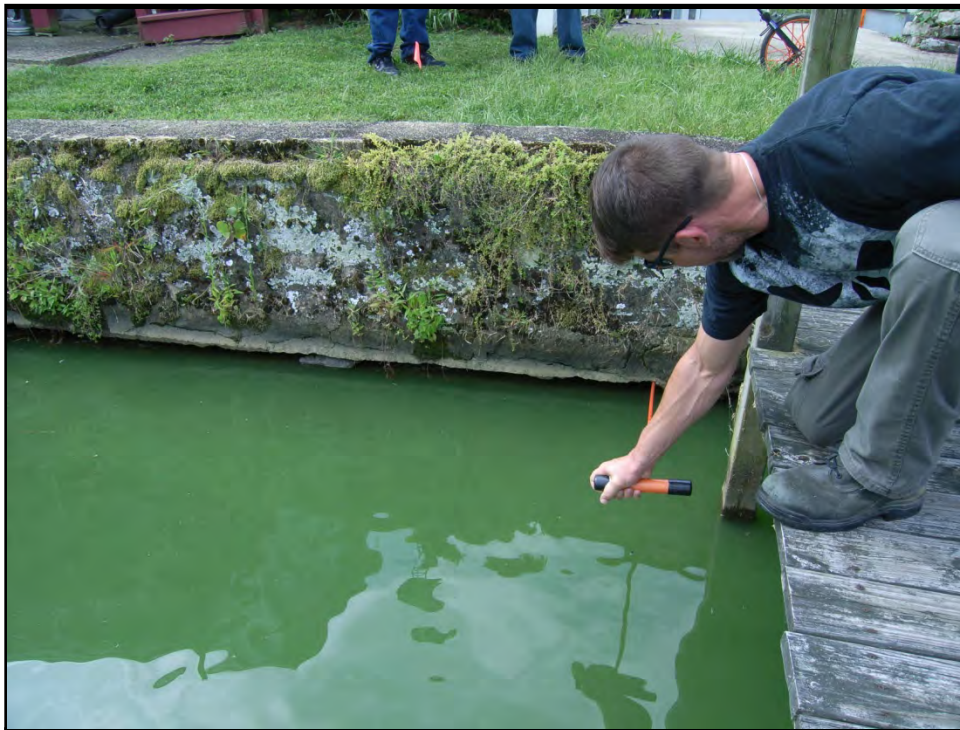
Photo 003 – Some voids in the masonry wall allow a tile probe to penetrate through the wall and contact the embankment.

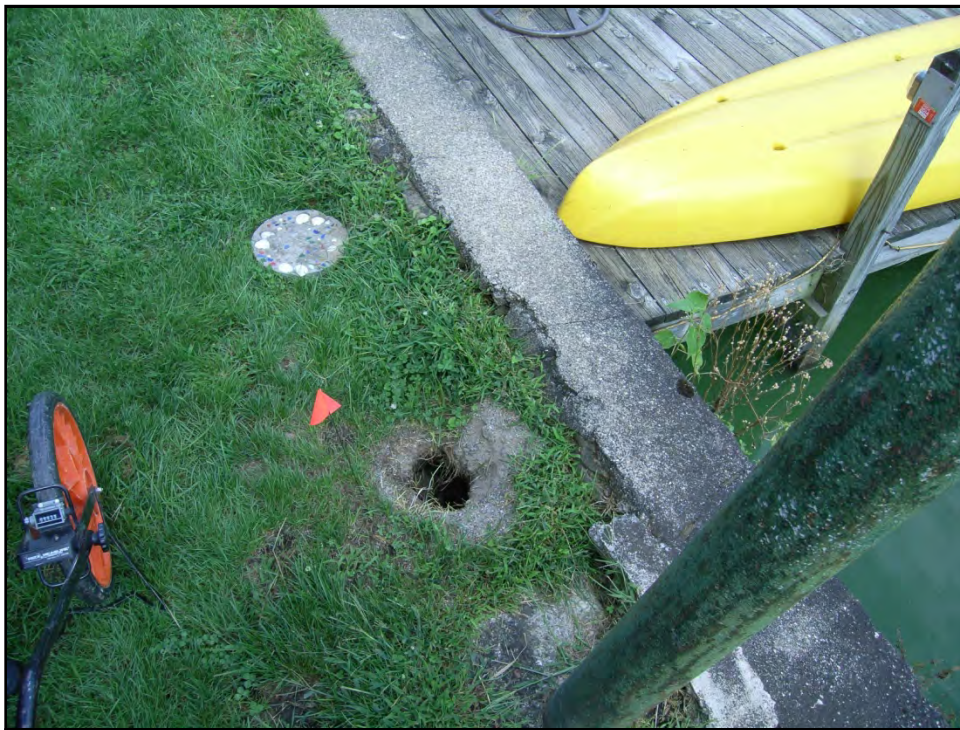
Photo 004 – One of many depressions observed behind the masonry wall along the west embankment.

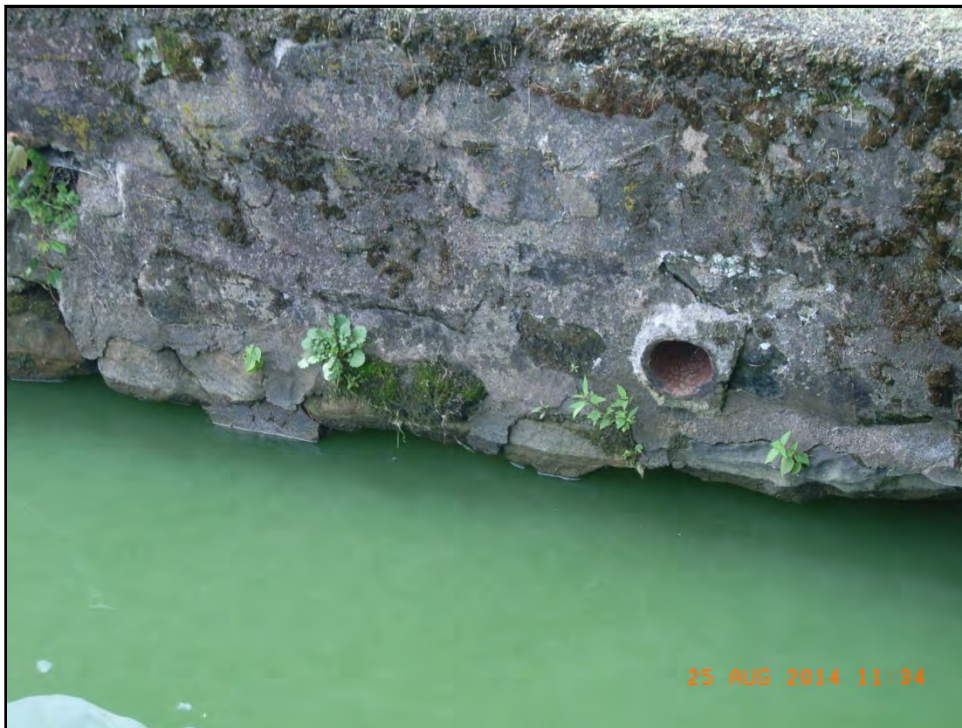
Photo 006 – Drainage pipes penetrate through the masonry wall along the west embankment.

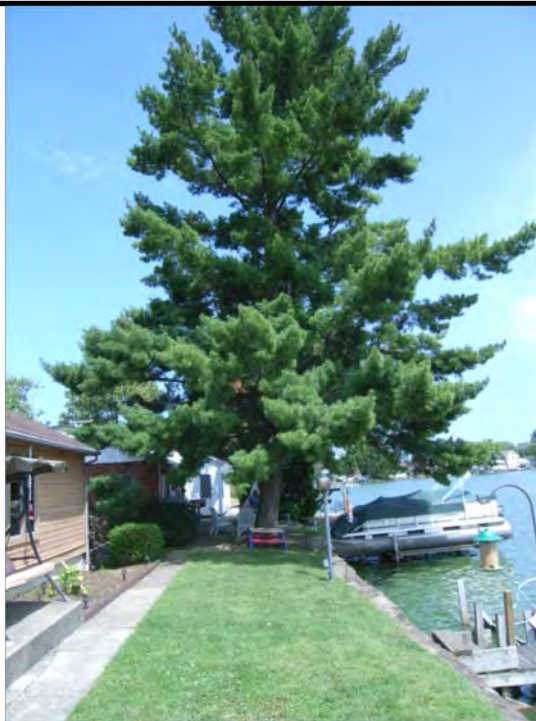
Photo 008 – One of many large trees rooted along the west embankment.

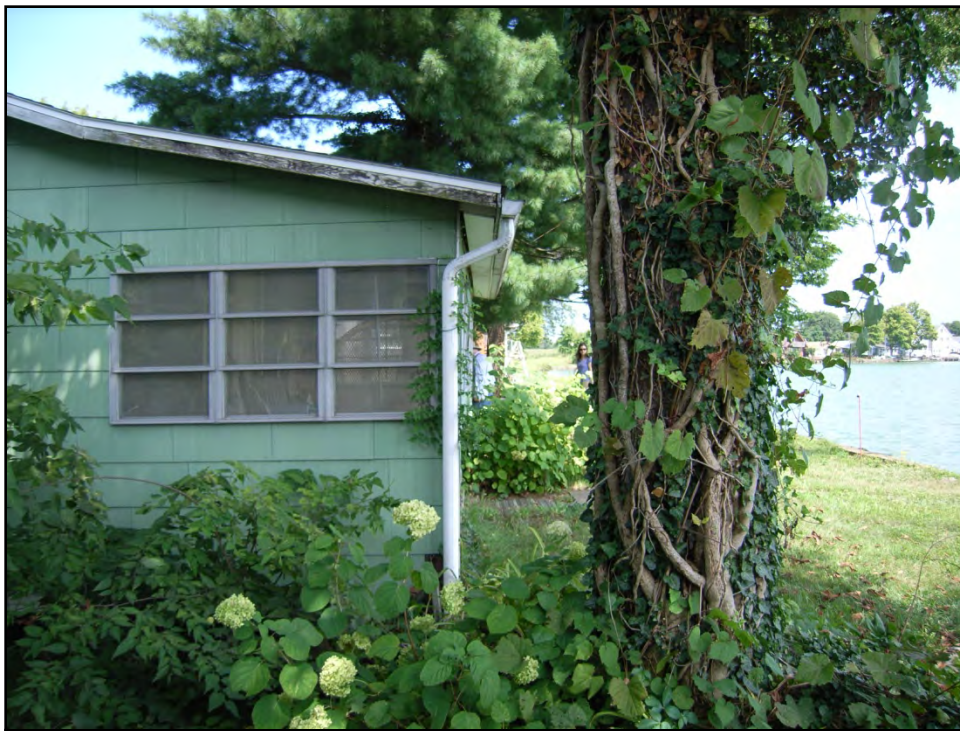
Photo 008 – Structure exhibiting distress resulting from embankment differential settlement and movement. Although not evident in this photo, the lakeside of house was several inches out of alignment.

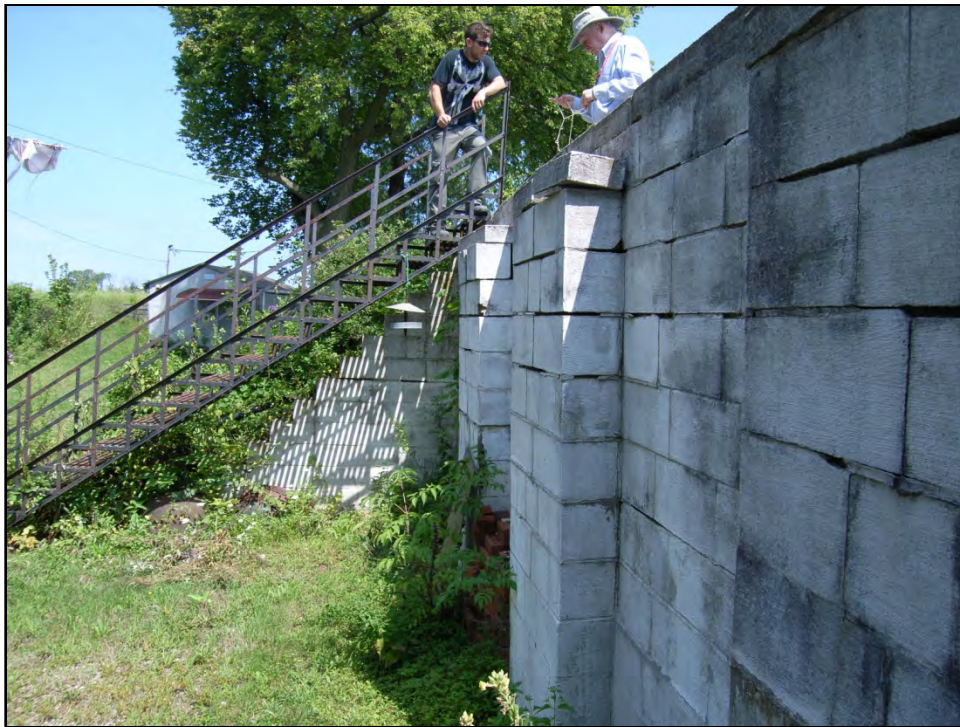
Photo 009 – A concrete block wall from an old structure is leaning 3-4 inches from vertical and concaved in alignment.

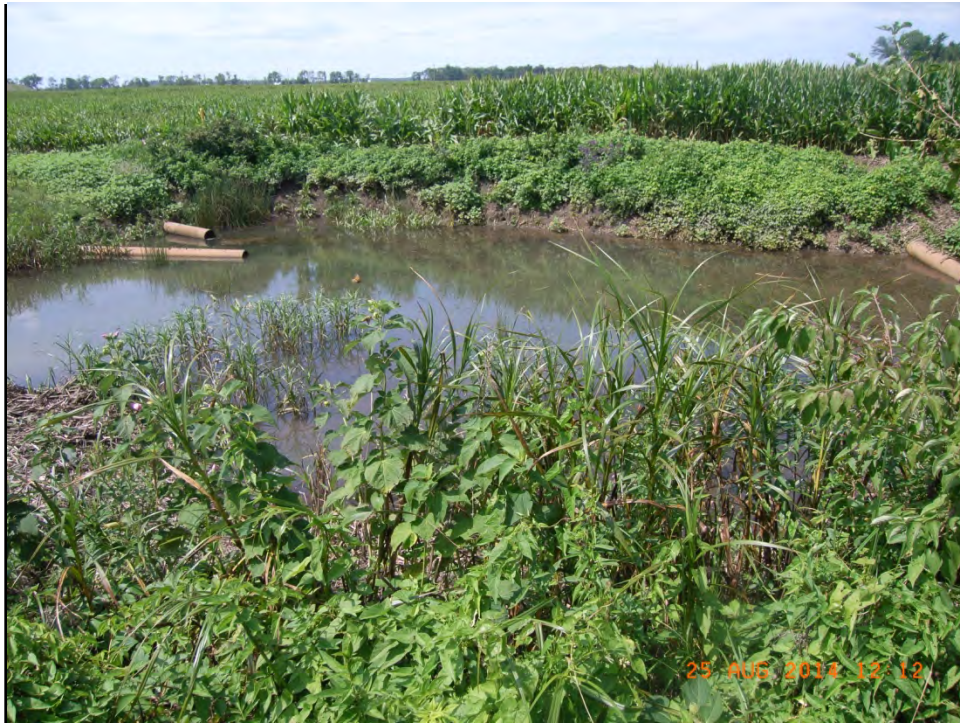
Photo 010 – Lagoon behind western embankment intercepts flow from reservoir through a steel pipe with no flap gate.

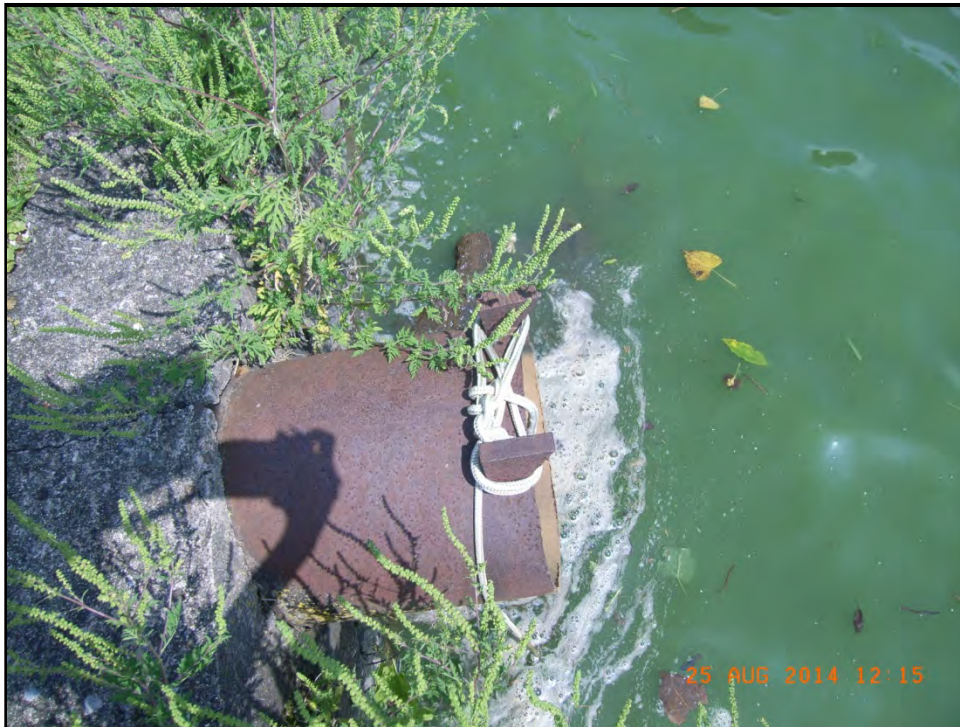
Photo 011 – Flap gate on a drainpipe connecting the pool to a downstream lagoon is missing.

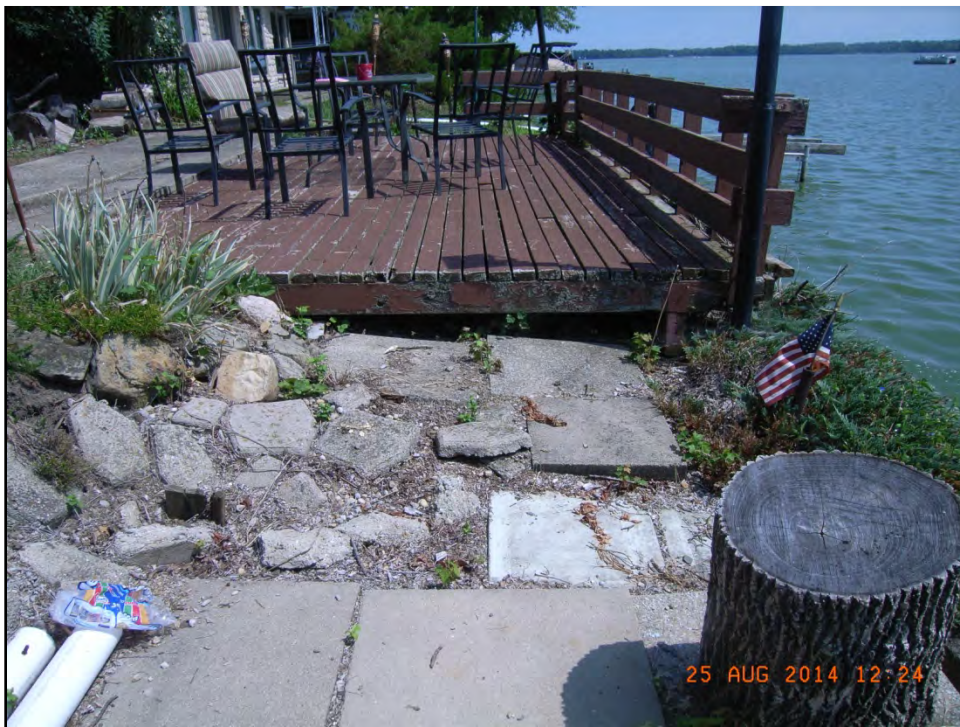
Photo 012 – Wood decks and patio structures inhibit monitoring the crest of the dam for signs of distress. Additionally they preclude grass growth which provides erosion protection of this earthen dam.

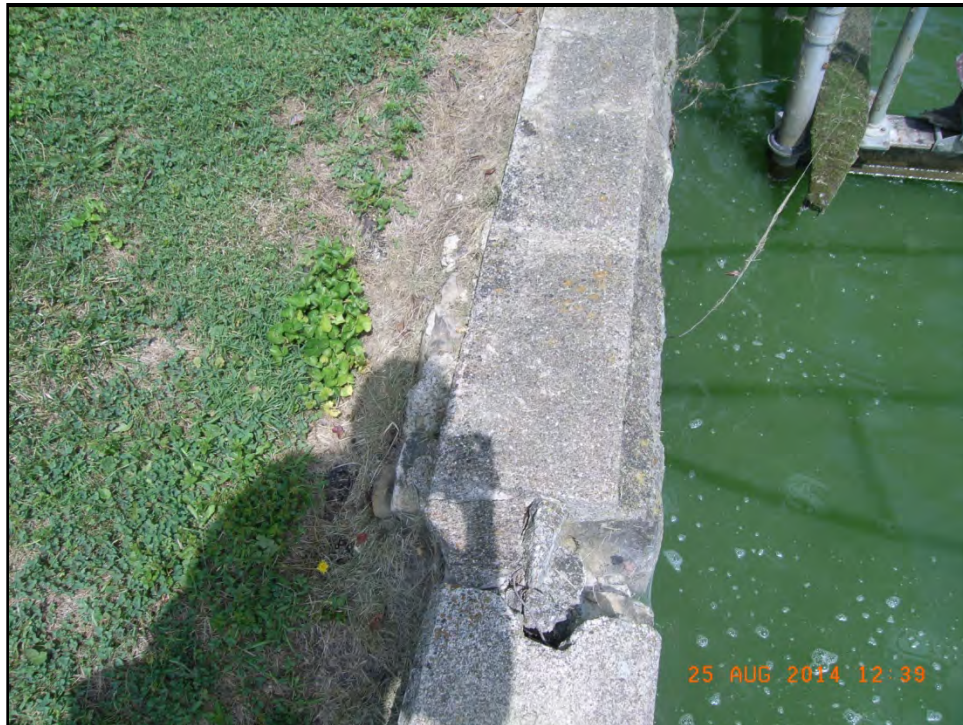
Photo 013 – One of many misaligned sections in the masonry wall.

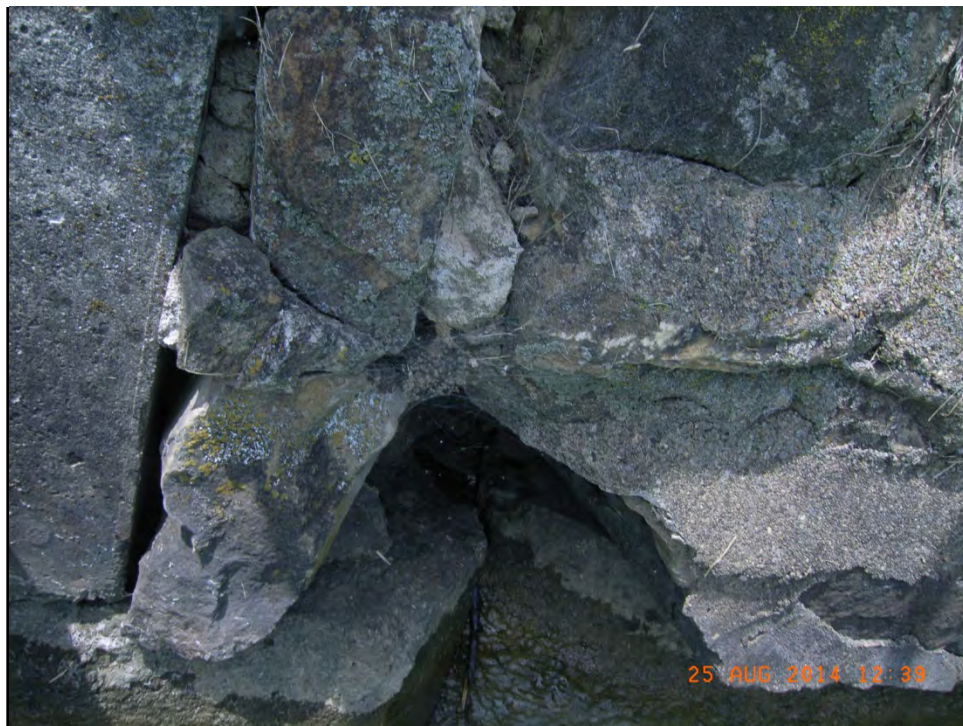
Photo 014 – Hole in base of misaligned segment of masonry wall.

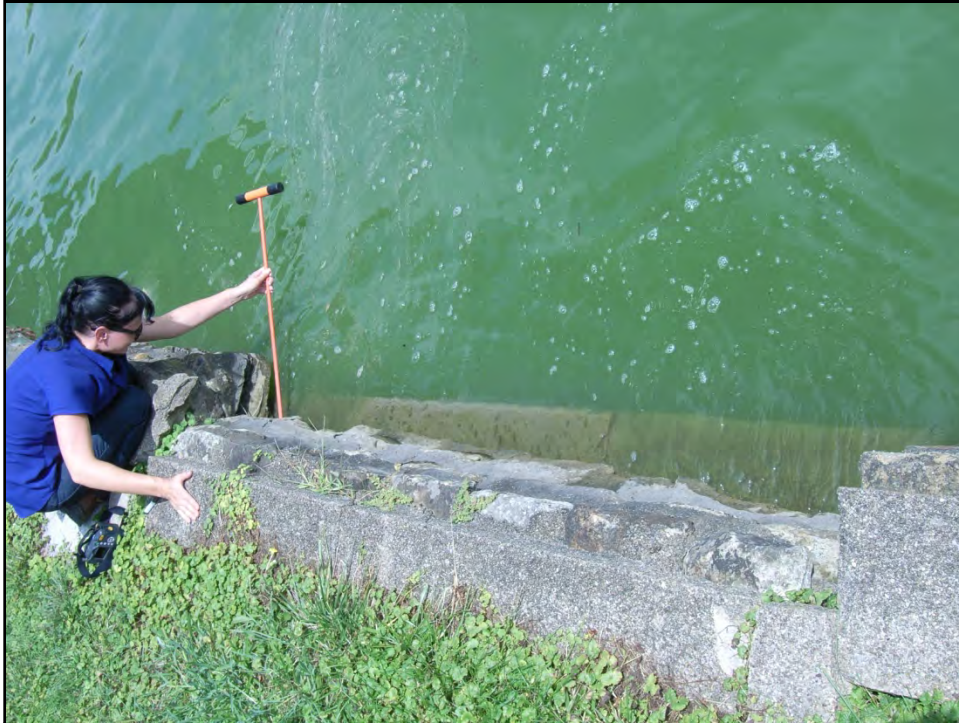
Photo 015 – Displaced masonry wall in western embankment.

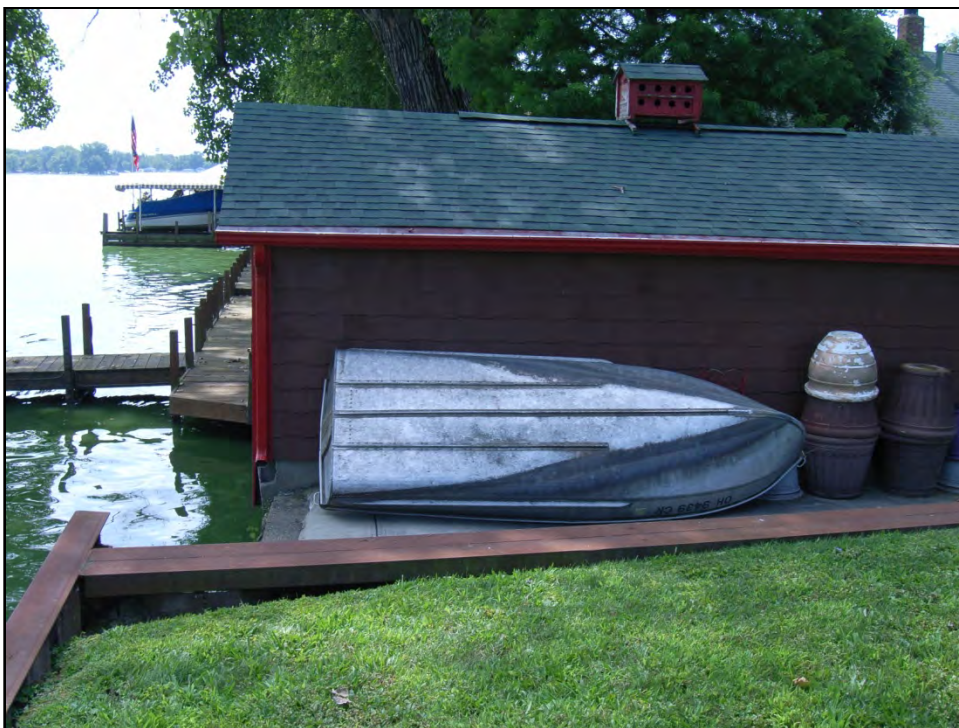
Photo 016 – Boathouse structure excavated halfway through the lakeside of the embankment by Mud Island.

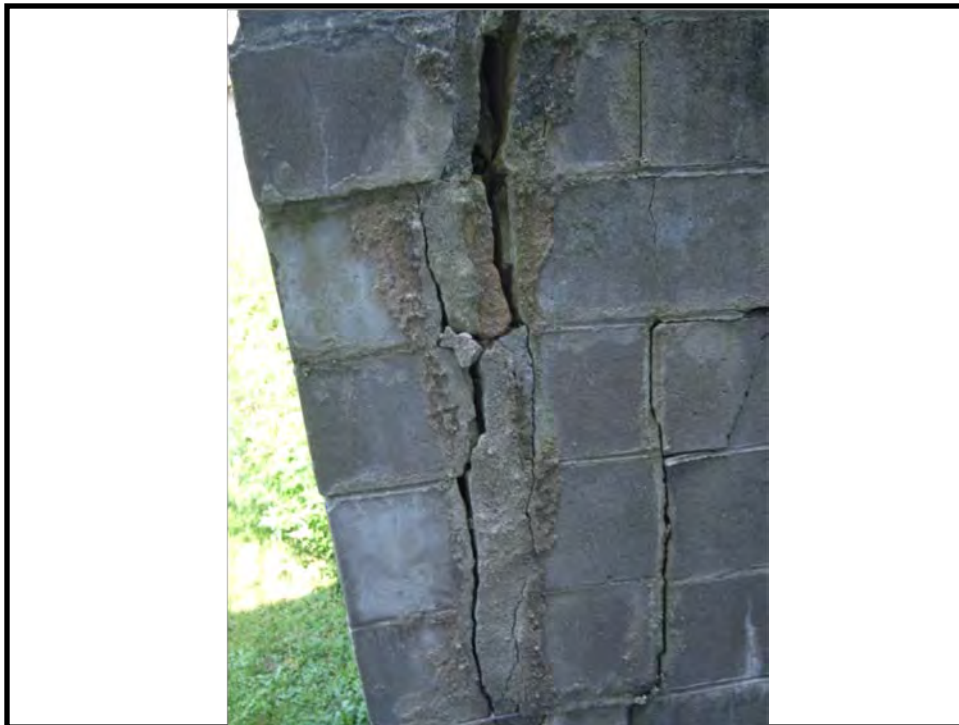
Photo 017 – Failing concrete block wall from an old structure built into the embankment.

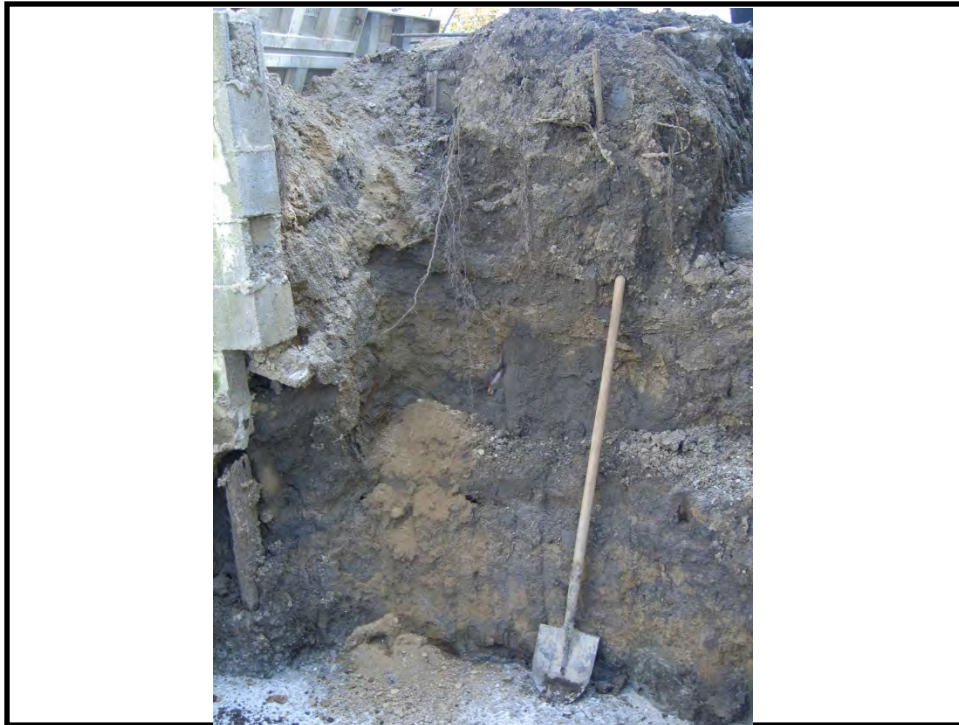
Photo 018 – Excavation into downstream face of embankment to construct new house. Note that no bracing is in use. This is very risky construction practice with regard to dam safety.

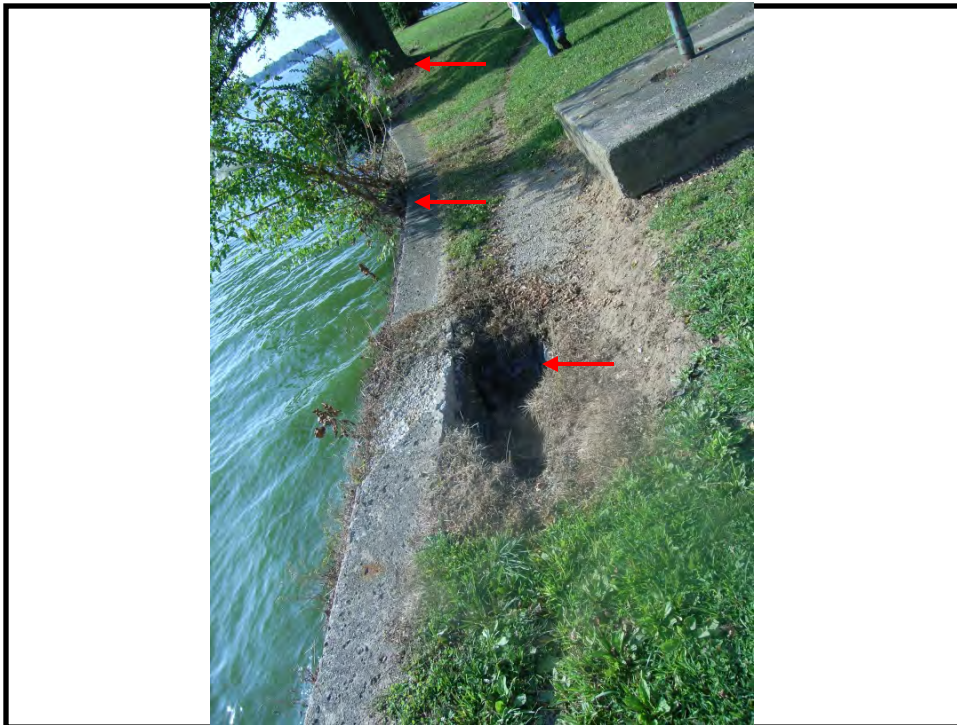
Photo 019 – Sinkholes along masonry wall and several trees growing through the wall.

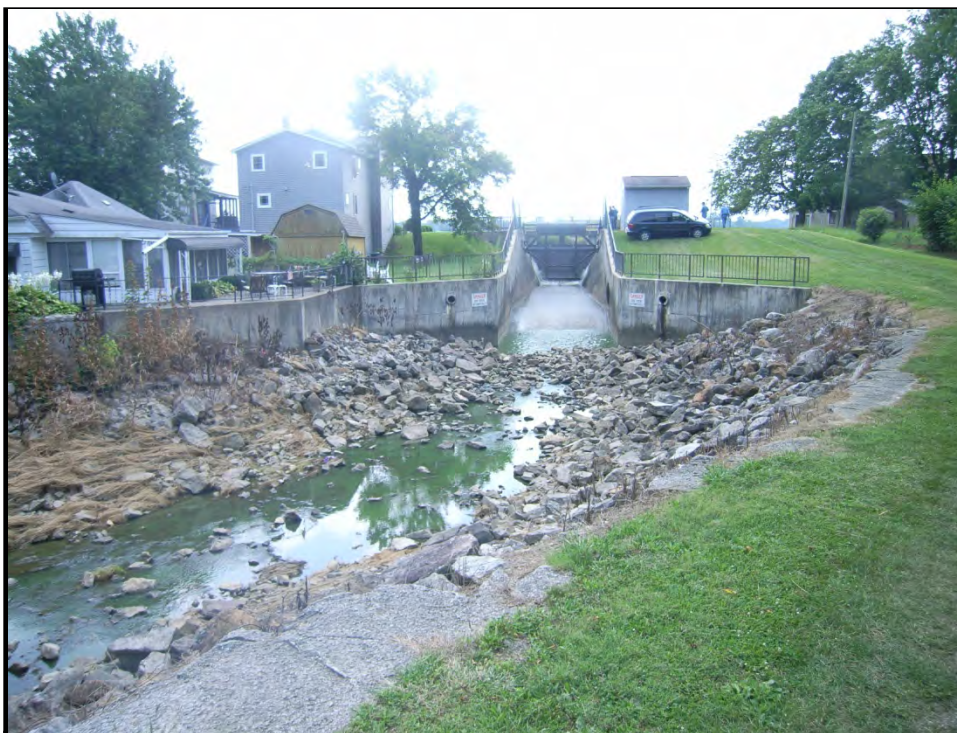
Photo 020 – Current flow from Amil Gate Spillway should be evaluated. Fish were observed to be trapped and dead in the rocks downstream.

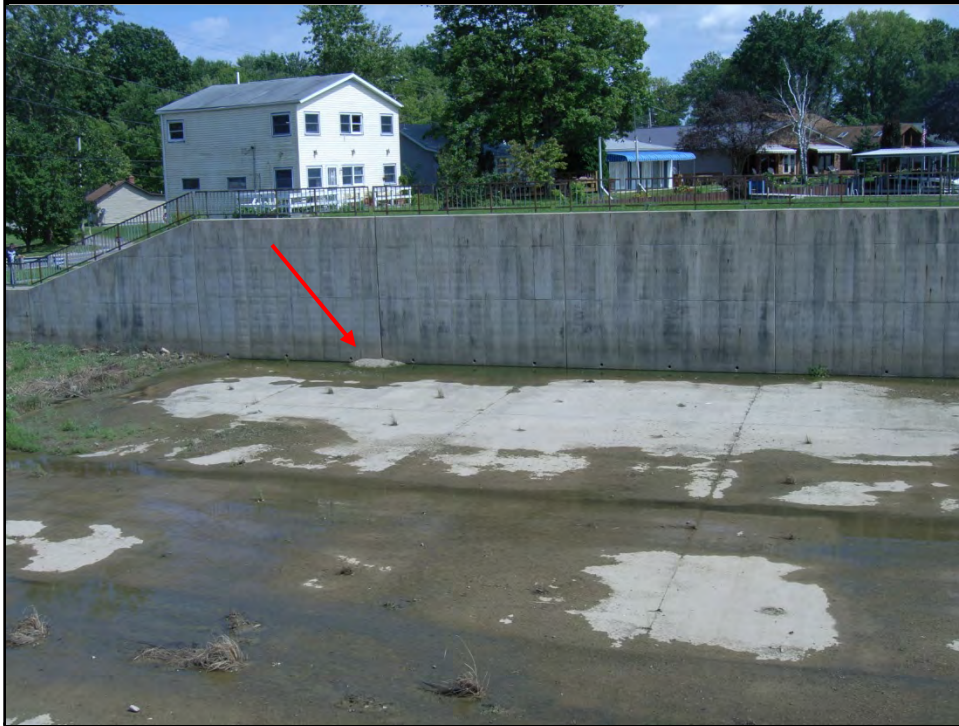
Photo 022 – Settlement along sidewalk behind eastern training wall at Sellers Point spillway.

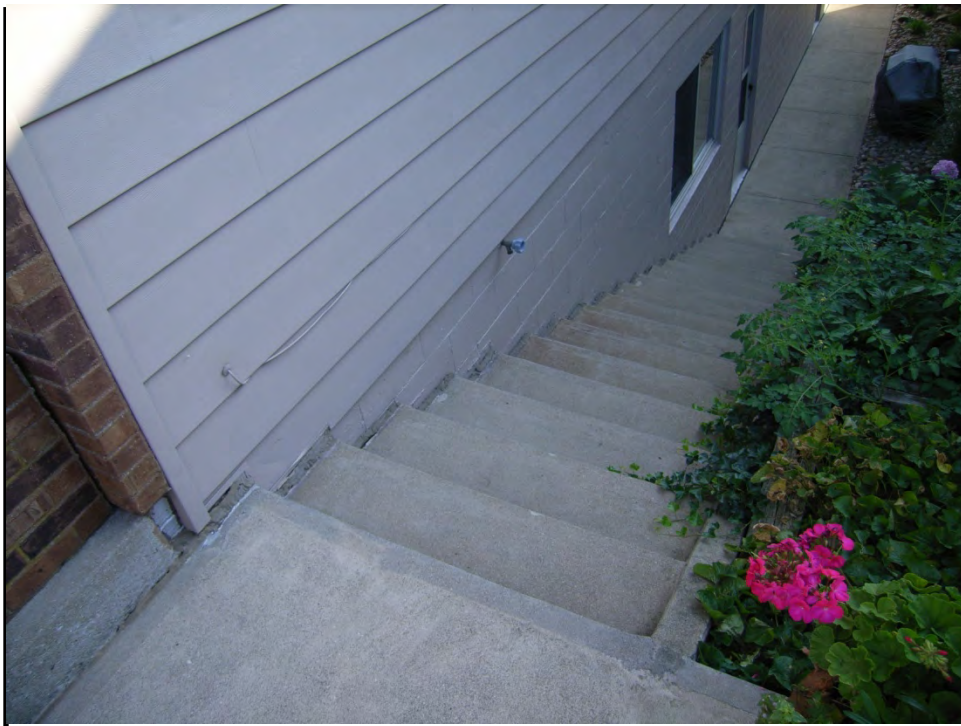
Photo 024 – Another photograph of same structure in Photo 023. Note that the sidewalk is misaligned with structure indicating embankment displacement.

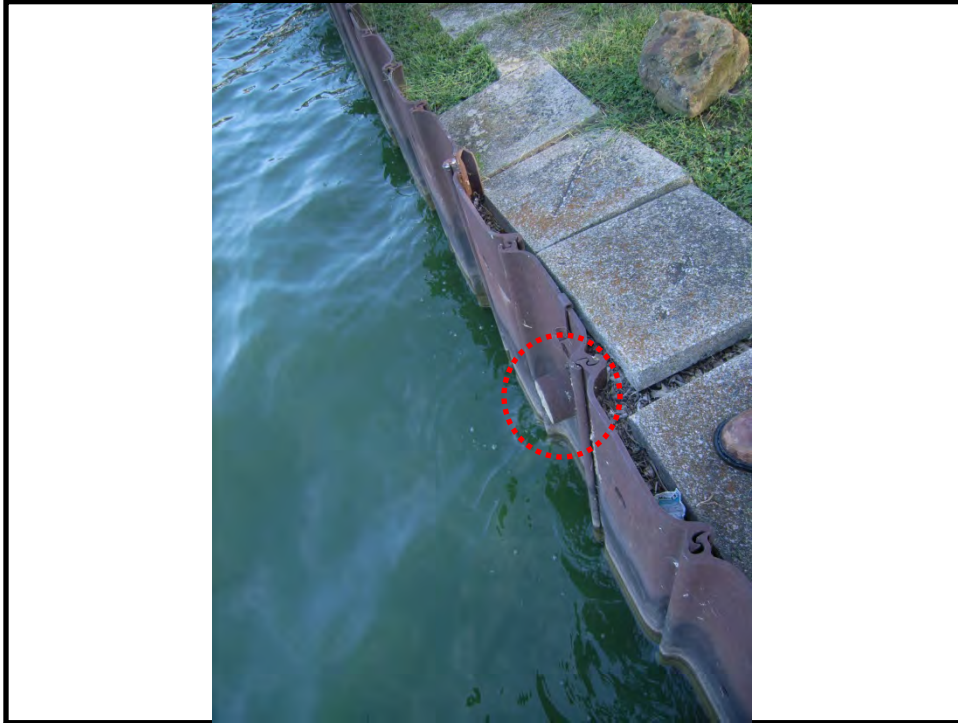
Photo 025 – Drain pipe penetrations through the sheetpile wall along north reach of the embankment.

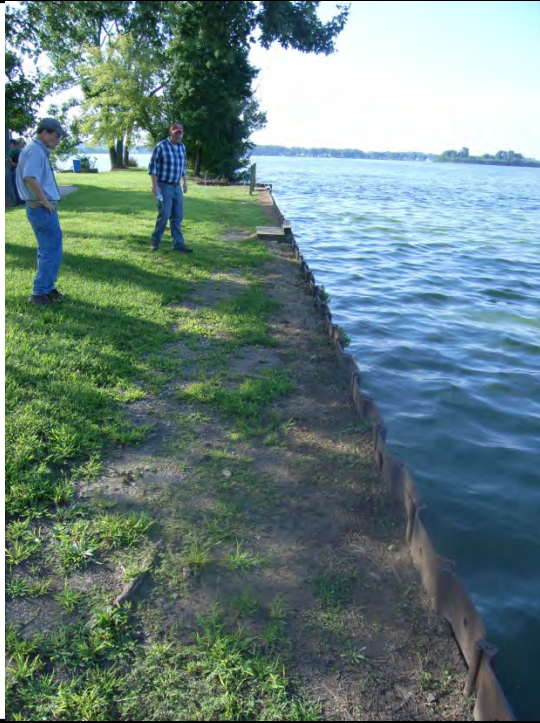
Photo 028 – Sheetpiling was bowed out and embankment fill material was settling behind Smitty's Tavern.

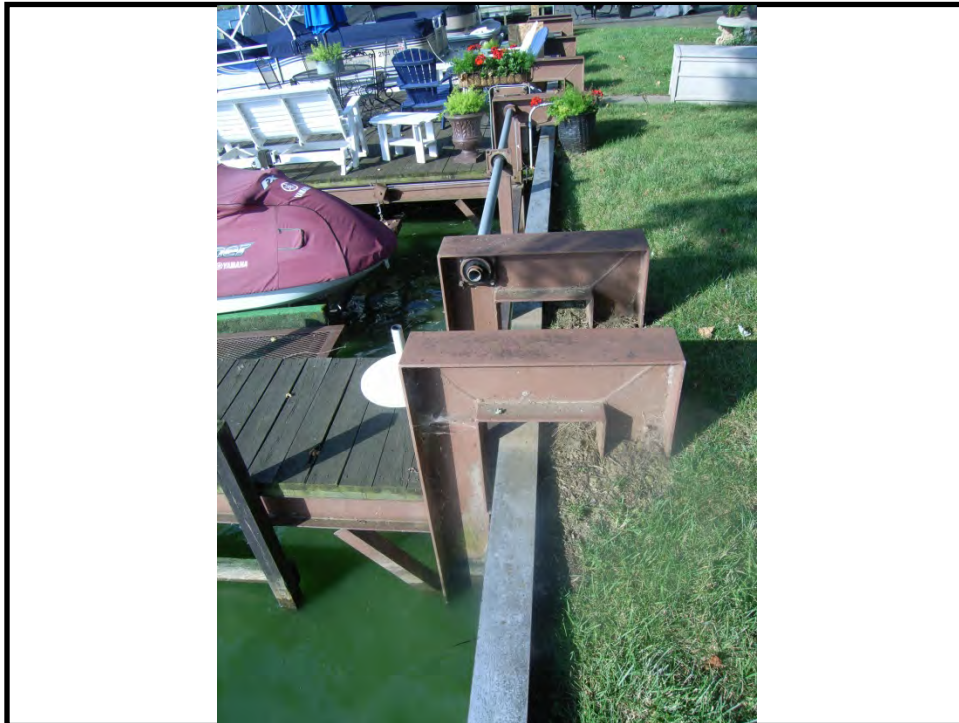
Photo 029 – Dock structures cantilevered off of the dam put stress on the sheetpiling that it was not designed for and have caused the wall to bow out.

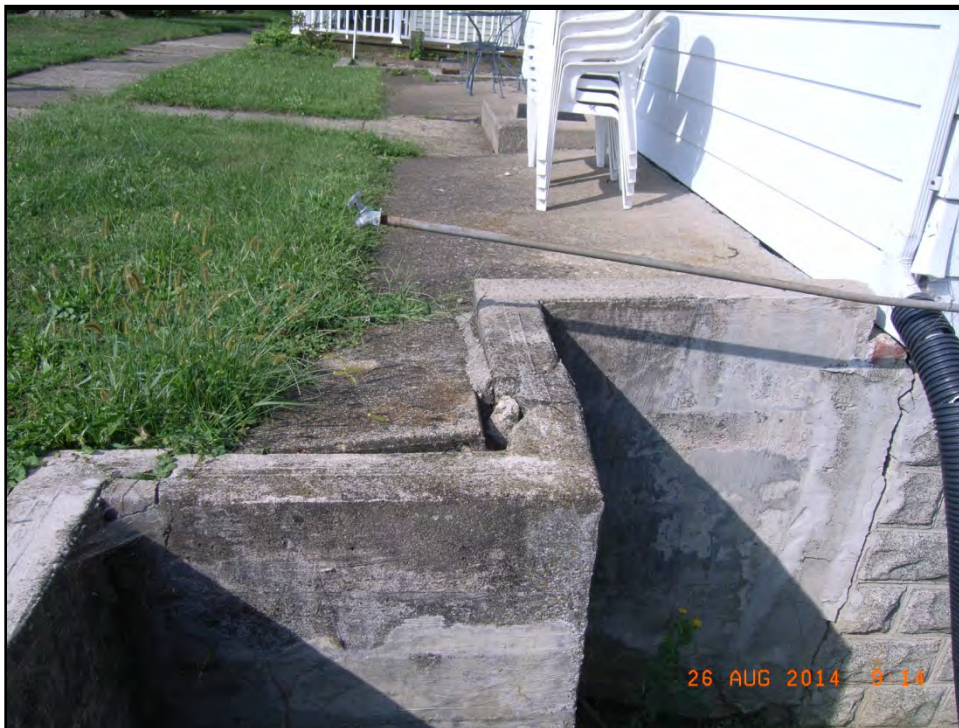
Photo 030 – House at Station 107+50 exhibiting significant differential settlement along embankment. Note settlement in crest between sidewalk and front of house.

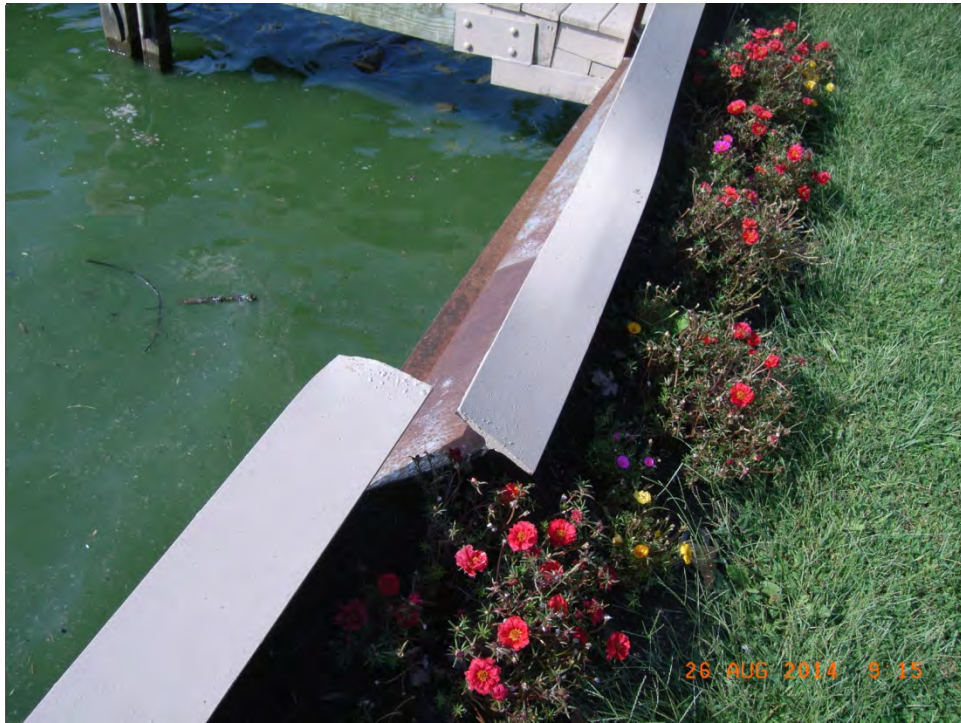
Photo 031 – Damaged waler on top of the sheetpiling.

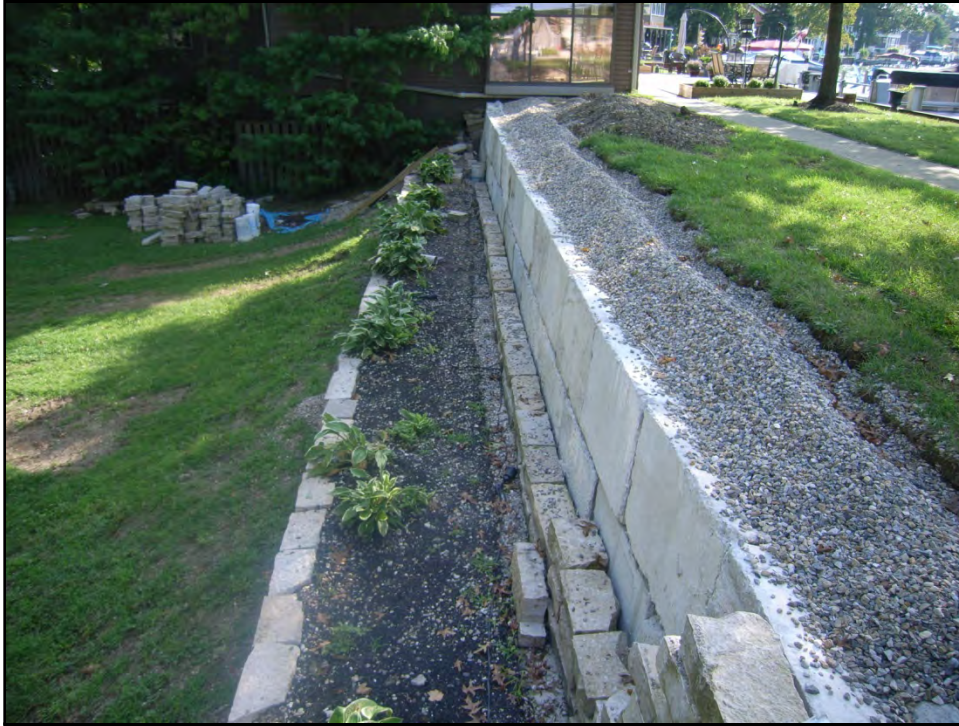
Photo 033 – Large segmental block wall constructed as a retaining wall. Note that the #57 stone used as drainage material is not filter compatible with embankment materials.

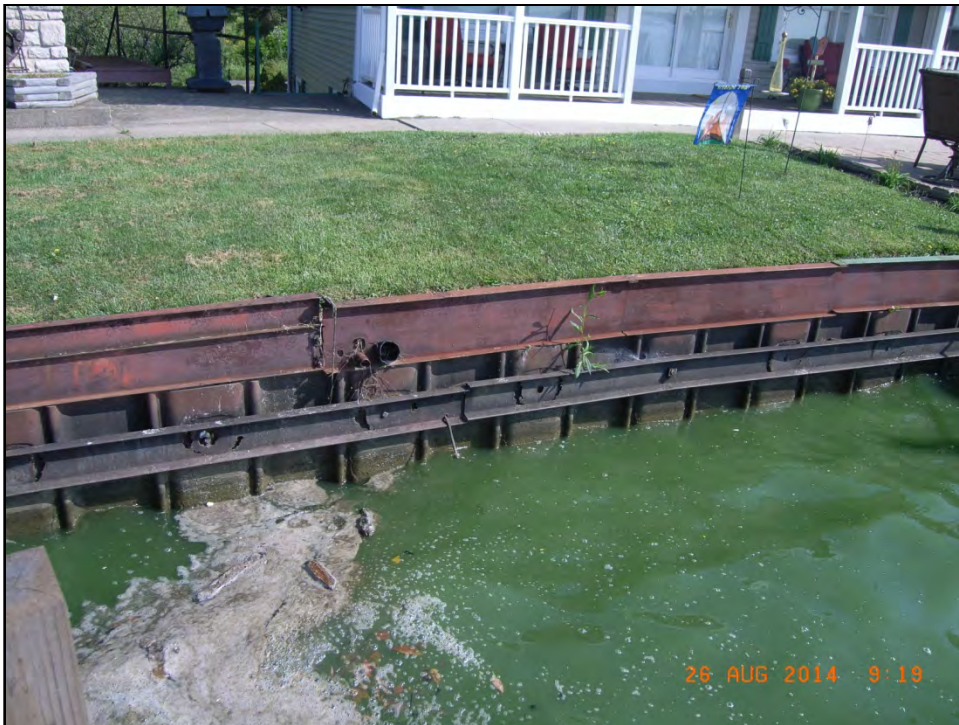
Photo 034 – Numerous rust holes were observed in the water along the 1948 sheet piling. Also, several pipe penetrations were observed.

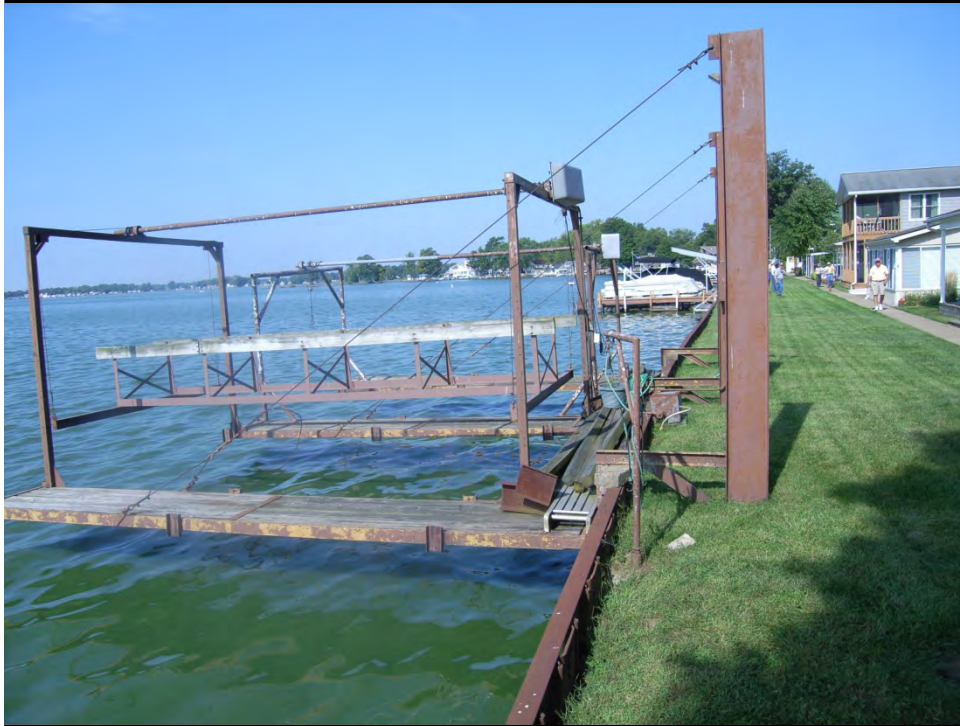
Photo 035 – Dock structures cantilevering off of the dam put stress on the sheet piling that it was not designed for.
