Buckeye Lake Dam

Fairfield and Licking Counties, Ohio

REVIEW OF PAST REPORTS AND EXISTING CONDITIONS AND RECOMMENDATIONS FOR INTERIM RISK REDUCTION MEASURES, OPERATION, AND MAINTENANCE

March 2015

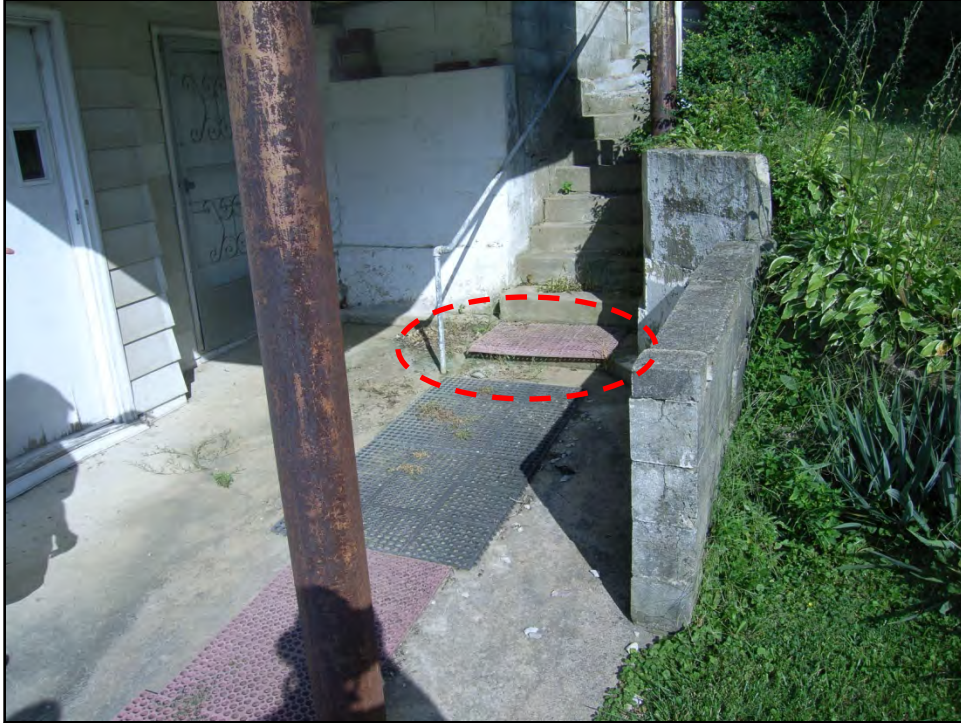
Photo 039 – Area of nearly year round seepage pointed out by resident. Station 152+50 along Black Diamond Bend. Note seepage was not occurring during the day of inspection.

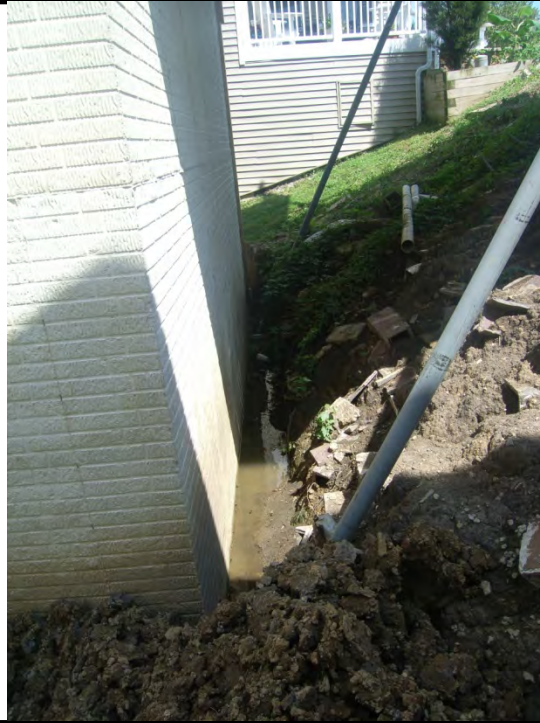
Photo 041 – Construction of new residential structure at the toe of the landward side of the embankment.

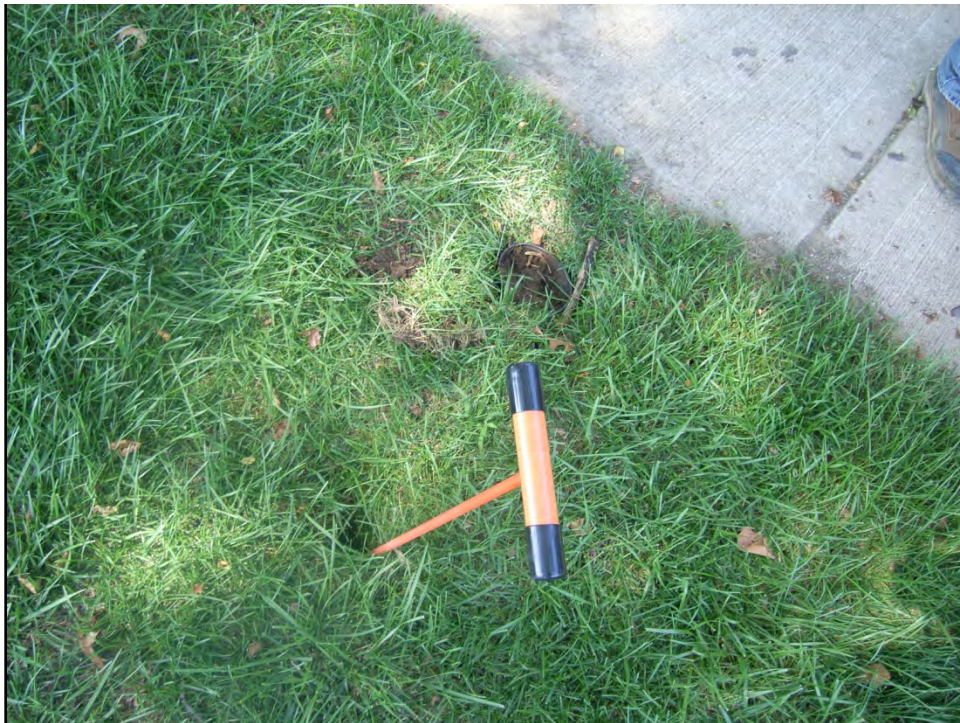
Photo 042 – Several depressions approximately 3.5' deep near centerline of crest between Stations 171+50 and 176+49.

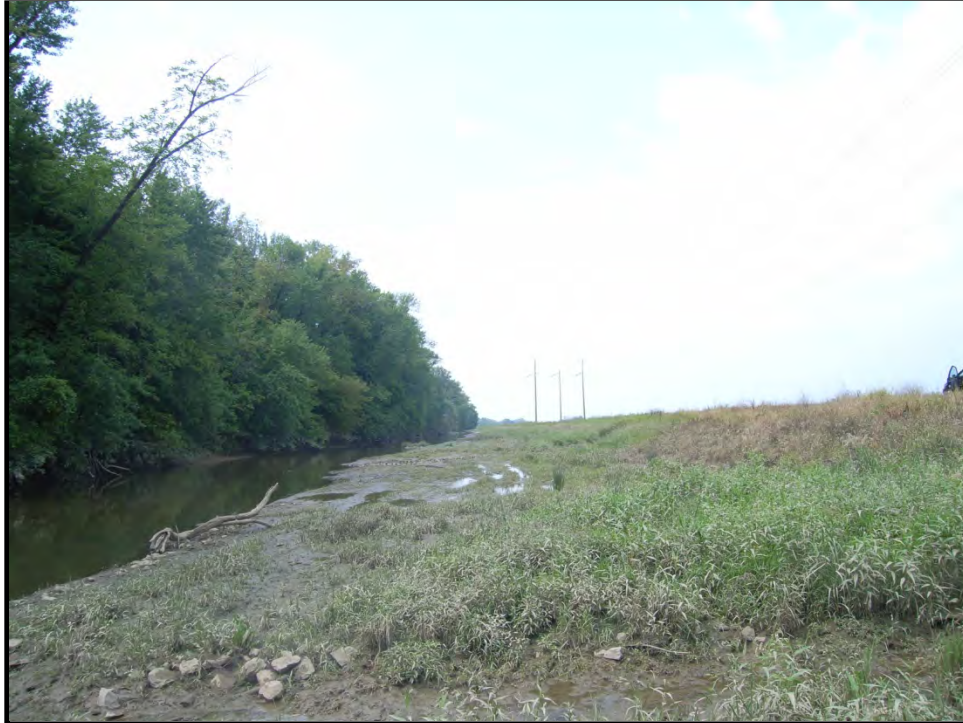
BUCKEYE LAKE 25 AUGUST 2014
Photo 043 – South Fork Licking River channel (facing upstream) after ODNr widening project. Note the recent deposition. A maintenance program will be essential to maintain conveyance capacity.

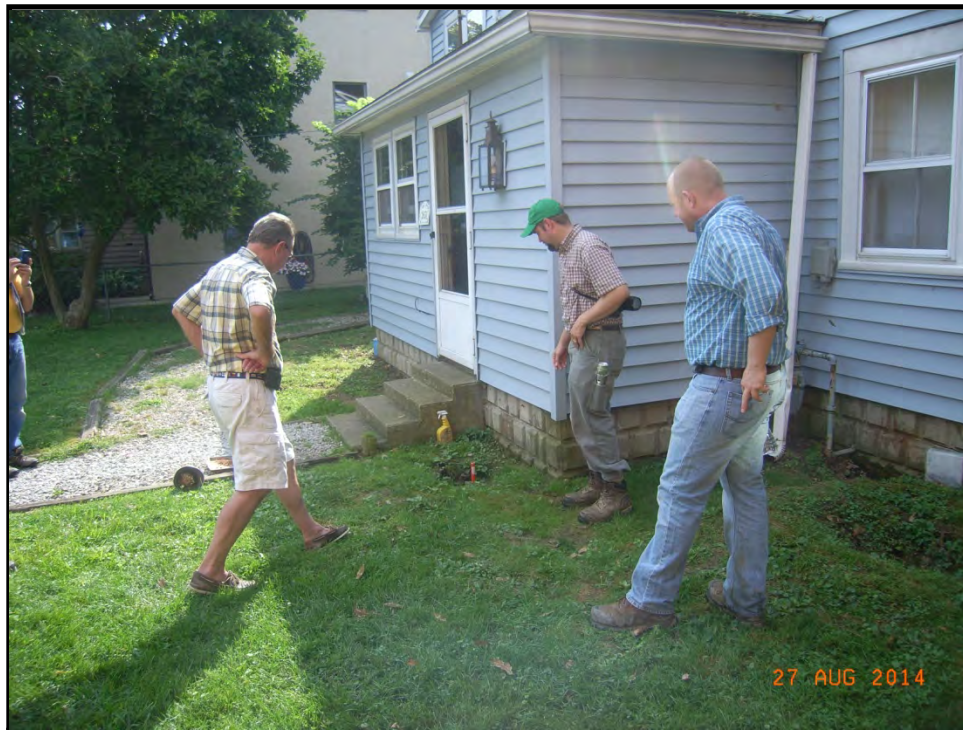
Photo 045 – Residence at Station 112+25 with several depressions at the ground surface possibly from boils. Soil was very soft and groundwater was very shallow at this location.

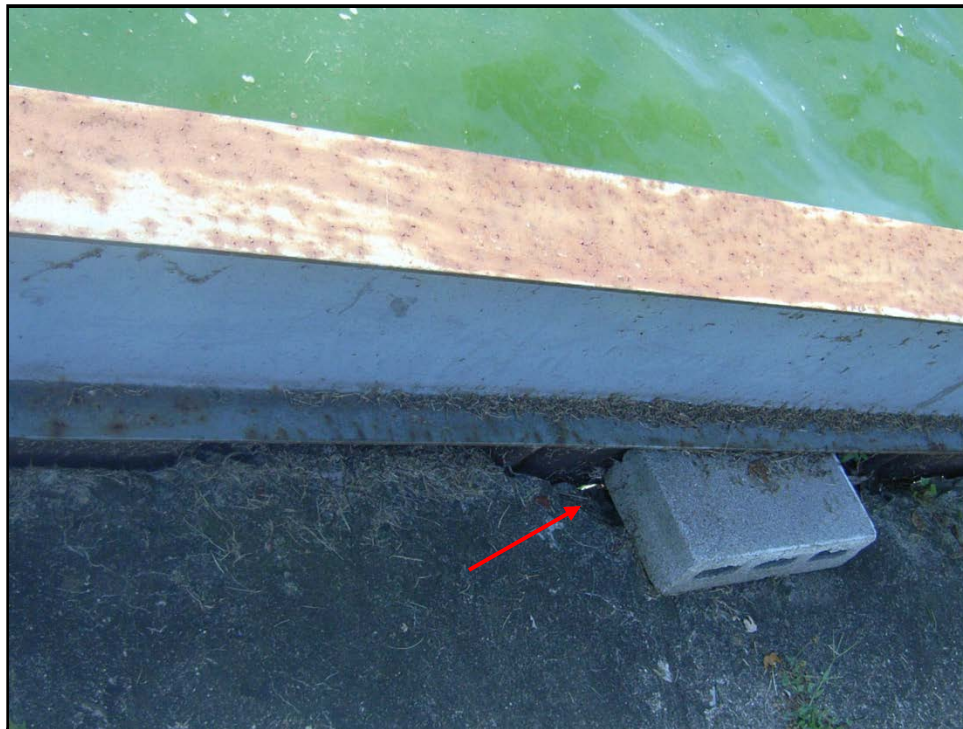
Photo 046 – Thinning and loss of sheetpile wall. Holes were observed through the wall. The wall beneath the water surface was not observed during the August inspection.

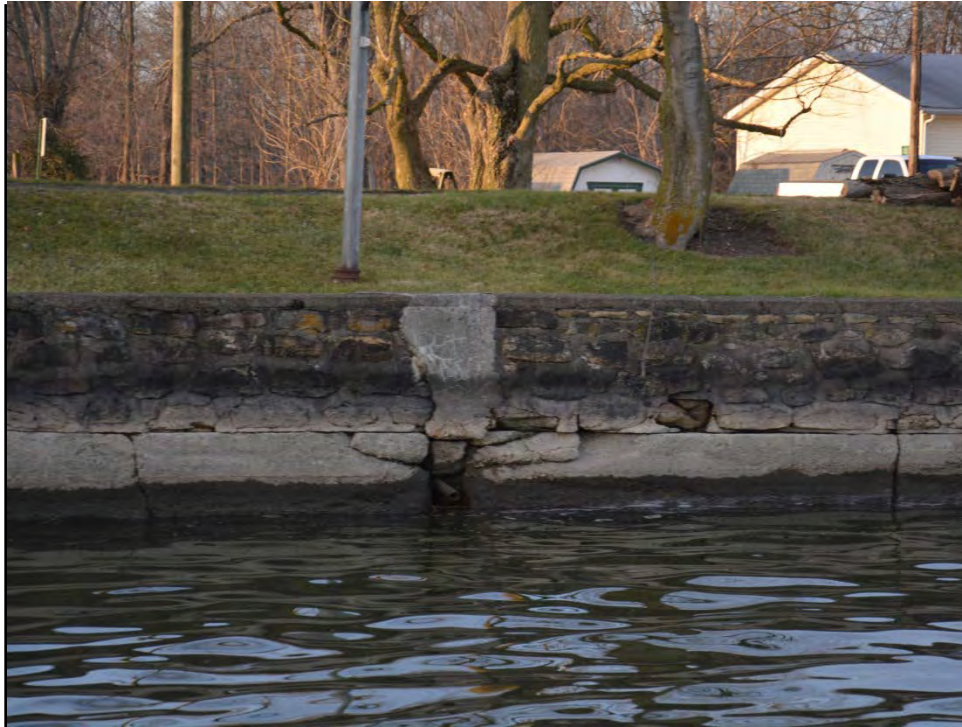
Photo 047 – Segment of masonry wall with attempted repair as observed at winter pool. Note the voids and cracks beneath the upper section of wall and the pipe penetration.

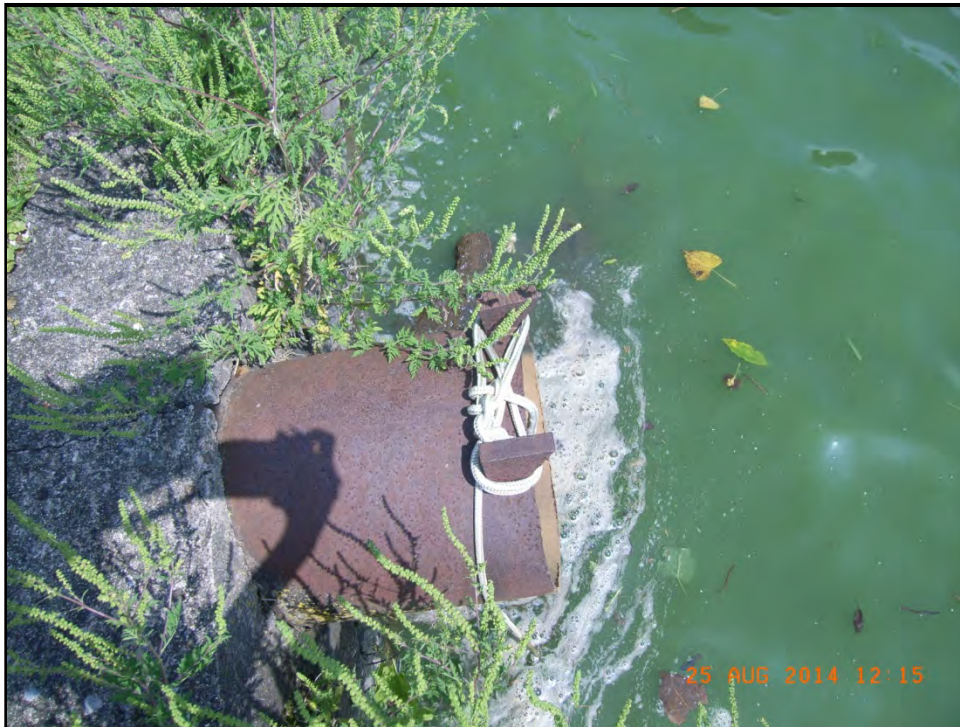
Photo 011 – Flap gate on a drainpipe connecting the pool to a downstream lagoon is missing.
