March 18, 2014

ASSESSMENT OF THE  
**CLARENCE E. MILLER BUILDING**

1587 Granville Pike, Lancaster, Ohio

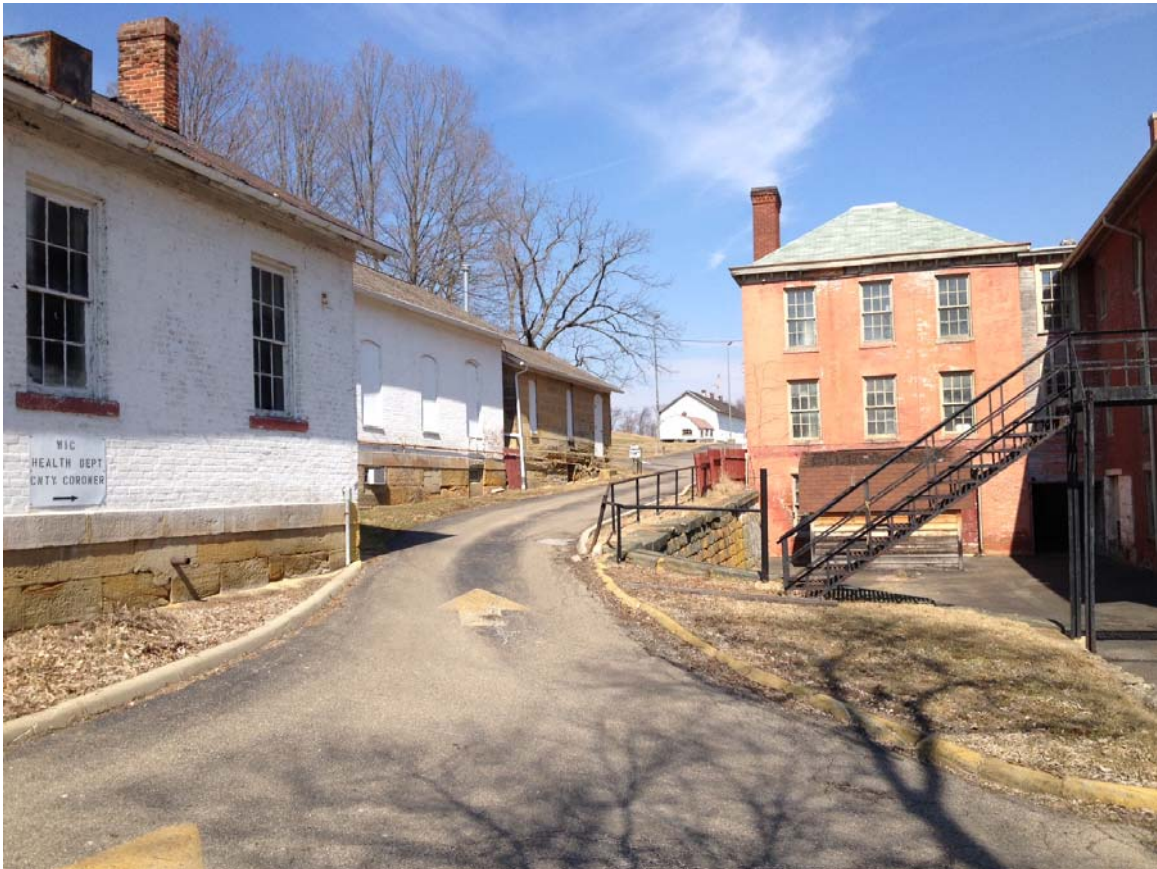
In 1986 a very narrow and somewhat dangerous driveway was paved through the tight space between the outbuildings and these new paired additions, with the masonry corner of one of the outbuildings on one side and only a pipe rail separating the drive from a steep drop-off at its other side where it ran adjacent to a parking area located next to the mechanical spaces at the first floor level. A wood bridge walkway was erected in the area between these two additions to provide access from the driveway to a rear entry door at the second floor.

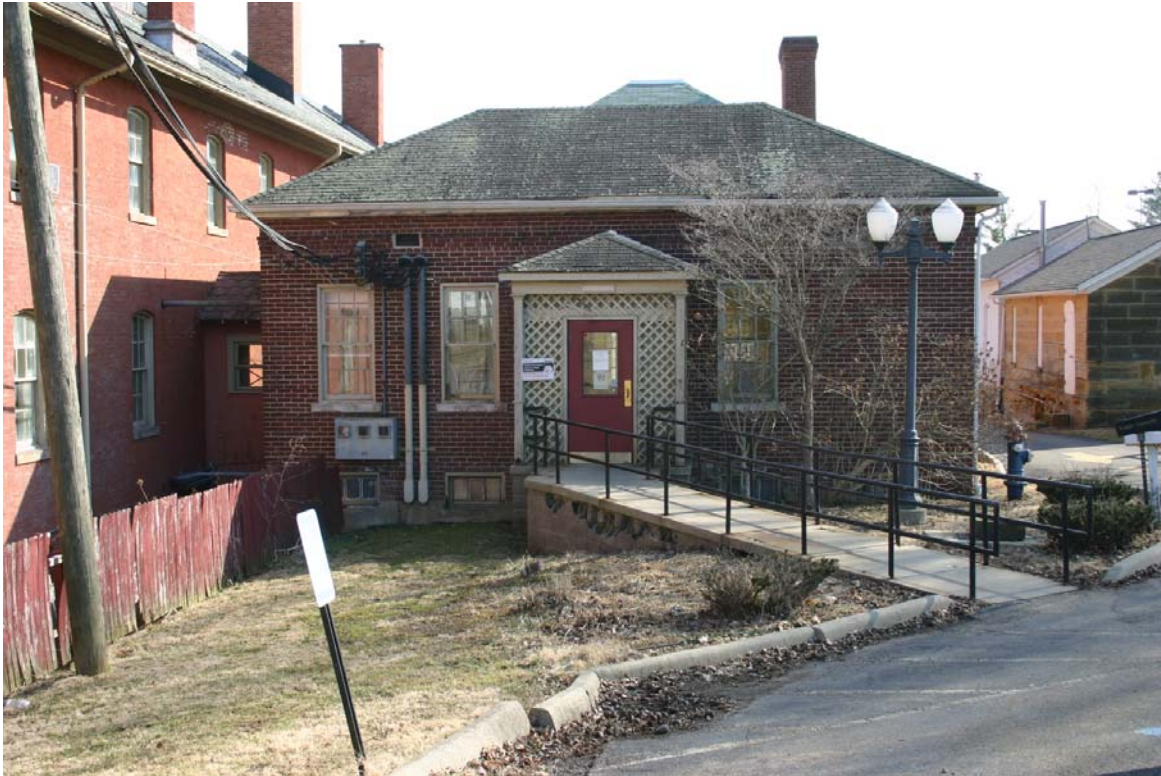
The remodeling of the rear addition included the installation of a new ambiguous second floor exterior entry door and a new narrow exterior ramp connecting this entry to the smaller of the two rear parking lots.

Because of its proximity to the parking lot, this new ramp and non-descript entry door became the new main entry to the building, and led to an extremely awkward interior path to the main second floor hallway via a series of small interior, ramped spaces.

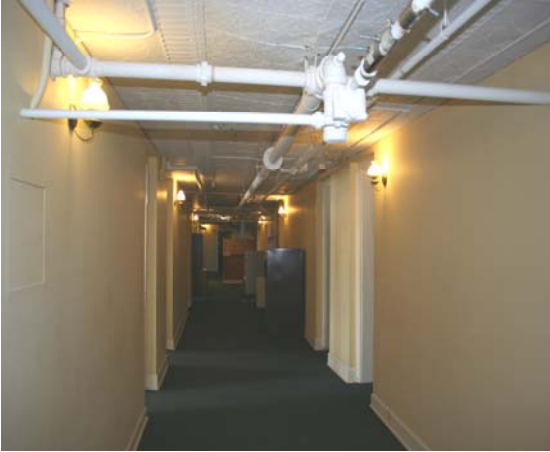
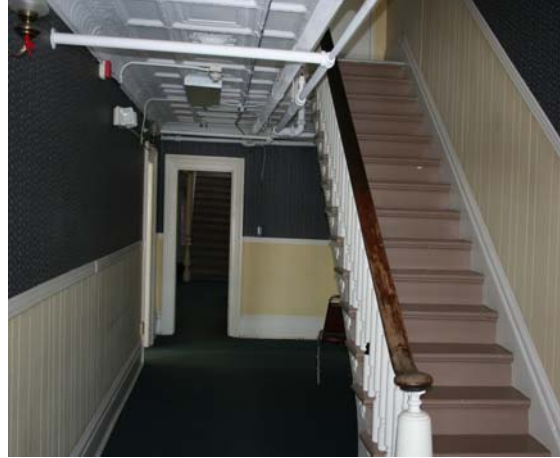
The 1986 upgrades included a new sprinkler system along with new electrical outlets and fluorescent lights throughout the building. The installation of the sprinkler piping appears to have been done for bare-bones costs, with many of the exposed main pipes running haphazardly through and across the hall ceiling spaces at varying heights under the tin ceiling panels and with main riser pipes running exposed next to existing walls. Most of the new wiring for the new outlets and lights was surface mounted (in wiremold) to the walls and ceilings, and in some instances, was run in conduit that was suspended from the hall ceilings as well. When added to the existing steam heat pipes that already ran exposed through the hall ceiling spaces and exposed vertically next to the walls, the sprinkler system and electrical work created a literal maze of crisscrossing pipes, conduits and wiremold at the ceilings and walls in some of the halls.

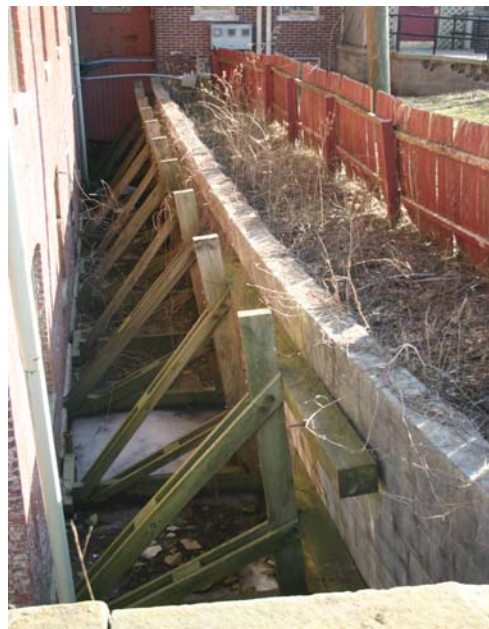
Sometime after the 1986 renovations, new data and phone wiring was installed in various areas throughout the facility, (all running exposed on the walls and ceilings), a new 24 car parking lot was added (located further up the hill), heavy timber bracing was added to the newly-installed-but-already-failing retaining wall along the west side of CEM and several sources of major roof leaks in the south wing were patched.

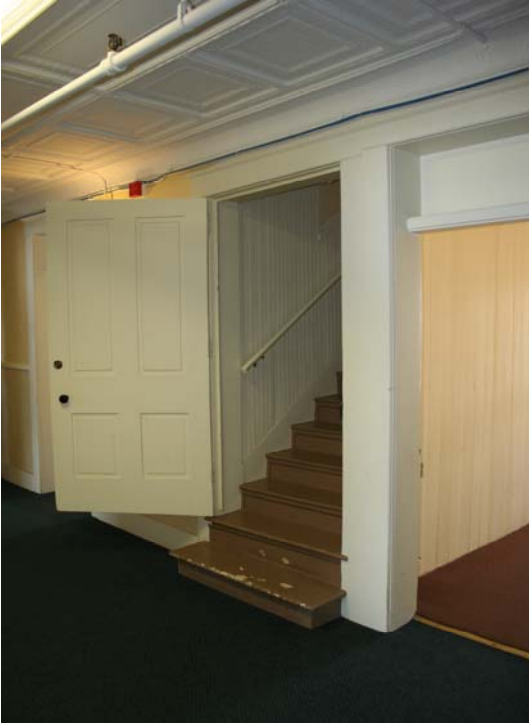
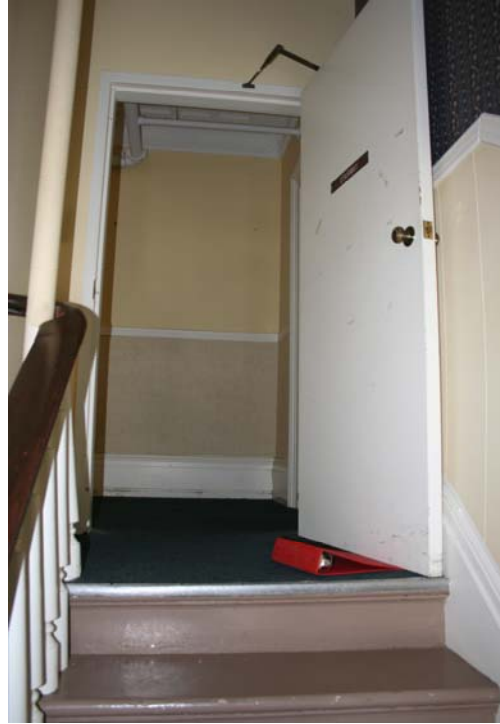
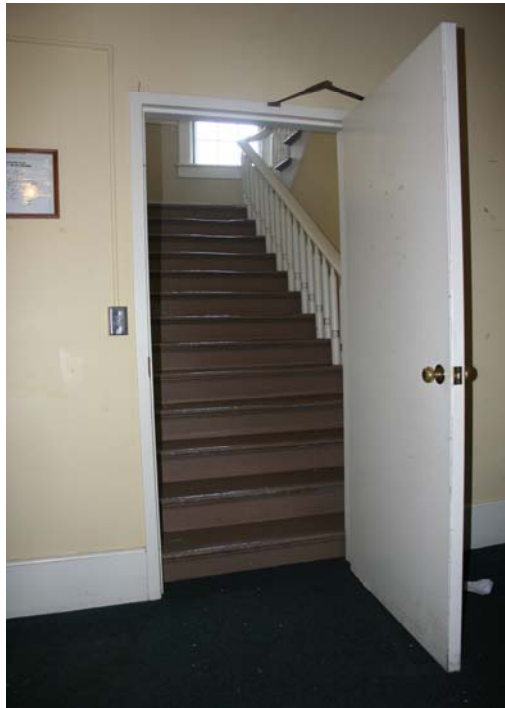
All of the existing egress stairs are not only non-code compliant, but, in the opinion of the author, they are also hazardous to the building occupants in multiple ways. None of them are salvageable.

Recommendation: Remove all existing stairways throughout the facility. Fill in all resultant floor openings to create additional office and hallway space. Add the following new, code compliant, fire rated, enclosed stairways connecting all three floors and the attic:
