**Supplement to
Vapor Intrusion Assessment
Existing Sheriff's Office and MSMJ
334 West Wheeling Street
Lancaster, Ohio**

Submitted to:
Fairfield County
Board of Commissioners
210 East Main Street
Lancaster, Ohio 43130

Prepared by:
Bennett & Williams Environmental Consultants, Inc.
98 County Line Road West, Suite C
Westerville, Ohio 43082
(614) 882-9122

January 2, 2015

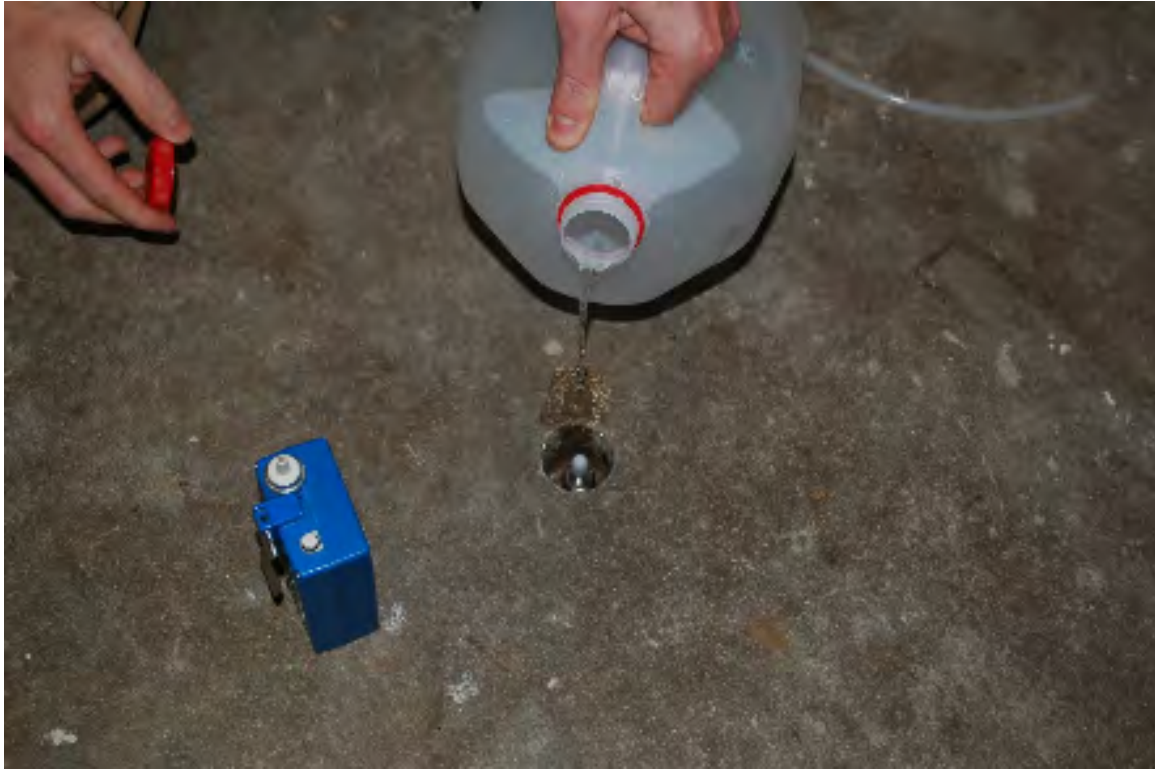
A-1. Integrity testing of sub-slab vapor sampling point SS-4 prior to sampling (November 4, 2014).

The sub-slab vapor sampling points were tested for leakage immediately before collecting the second of two sets of sub-slab vapor samples on November 4 and 5, 2014. Testing performed inside the Sheriff's Office and the MSMJ was conducted with a Deputy escort. The test was conducted in accordance with the manufacturer's instructions for the Vapor Pin™ assembly. The stainless steel cover was removed by using a #14 Spanner tool. The plastic cap on the Vapor Pin™ was left on and distilled water was poured into the annulus surrounding the Vapor Pin™. Care was taken not to add water higher than the elevation of the top of the Vapor Pin™. No observations of air bubbles were made when the distilled water was first added to the hole.

The distilled water was allowed to hydrate the concrete in the immediate vicinity of the Vapor Pin™ while the sampling pump was calibrated. The water level around the Vapor Pin™ was noted and sample collection was initiated. During the first five minutes of sample collection, the water level around the Vapor Pin™ was critically observed. No water level changes at any of the sub-slab vapor sampling locations were observed during this time. The Vapor Pins™ were then considered to have integrity and sample collection was continued. If there had been evidence of air bubbles or a noticeable water level drop, the sampling would have been discontinued and either another Vapor Pin™ installed or the defective one re-sealed and re-tested.

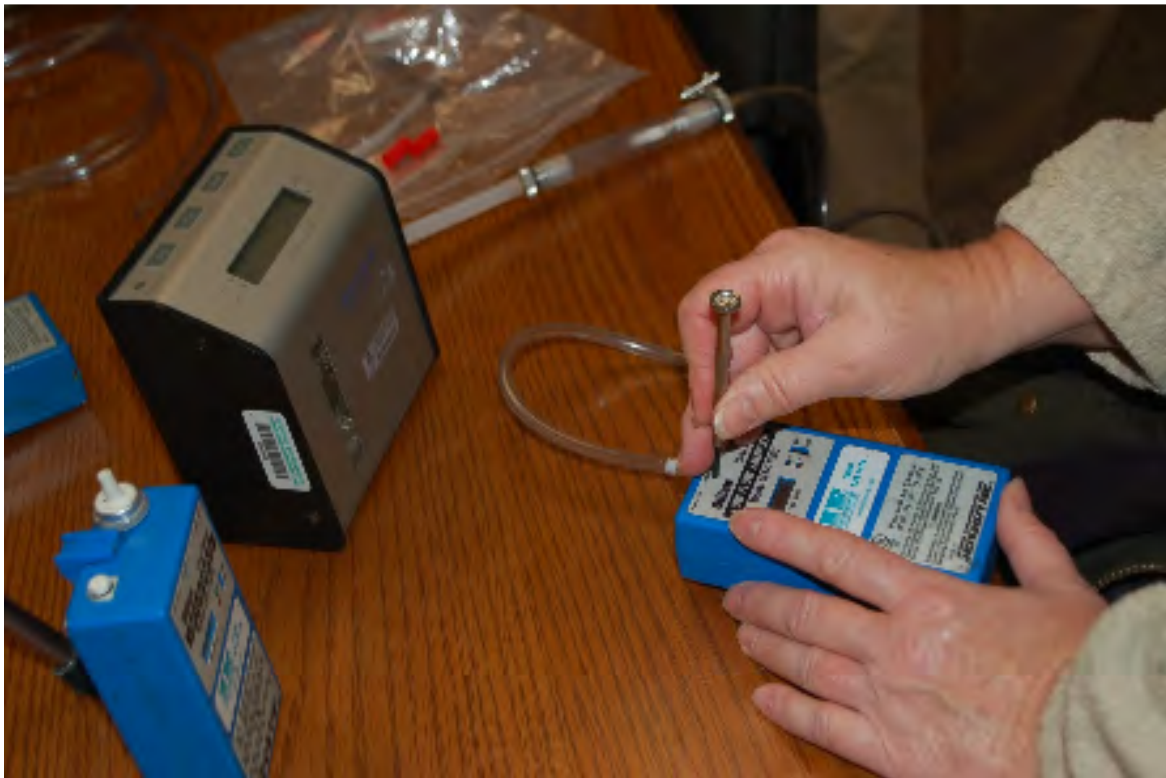
A-2. Calibration of Gilian low flow sampling pump at AA-2 using DryCal flow meter and naphthalene “calibration tube” (November 4, 2014).

Samples were collected by connecting ¼-inch ID vinyl tubing to the inlet end of a Gilian Dual Mode Low Flow Sampler LFS-113DC to the outlet end of a Gilian universal holder system. Both ends of the glass naphthalene tube (XAD-2®, Lot No. 8942; Exp. Jan/2019) from Test America were broken with a pair of needle nose pliers and placed inside the tube holder with the flow arrow pointing toward the pump. The tubes were elevated to a representative breathing zone exposure height (Table 1) by attaching the tube holder to the top of an expandable tripod. Samples were collected by pumping at a rate of 460 mL/min for 600 minutes (10 hours), resulting in a total pumped air volume of 276 liters. Due to the long pumping time, the pumps were monitored at approximately intervals of 15 minutes (access permitting) to ensure that sampling was not interrupted by equipment failure or other problems. No problems were encountered during collection of the samples. Appendix A contains pictures of the collection of the naphthalene indoor ambient air samples.

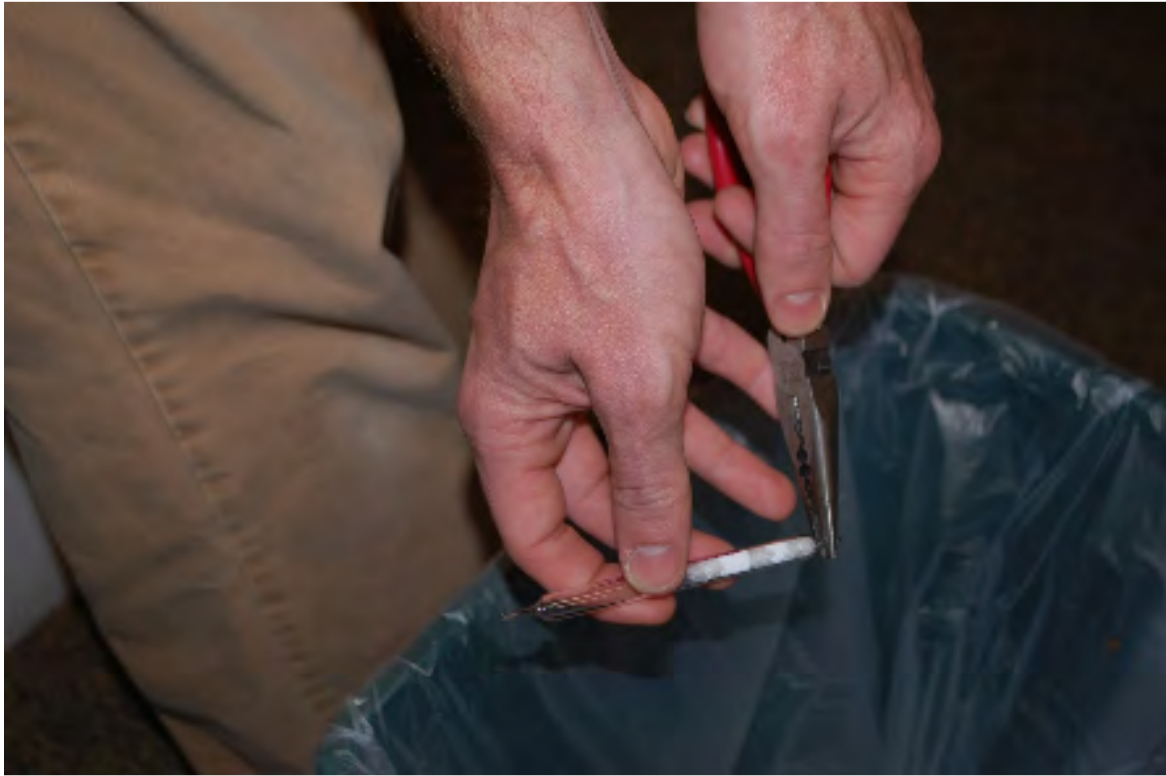
A-3. Breaking ends of naphthalene tube prior to sample collection (November 4, 2014).

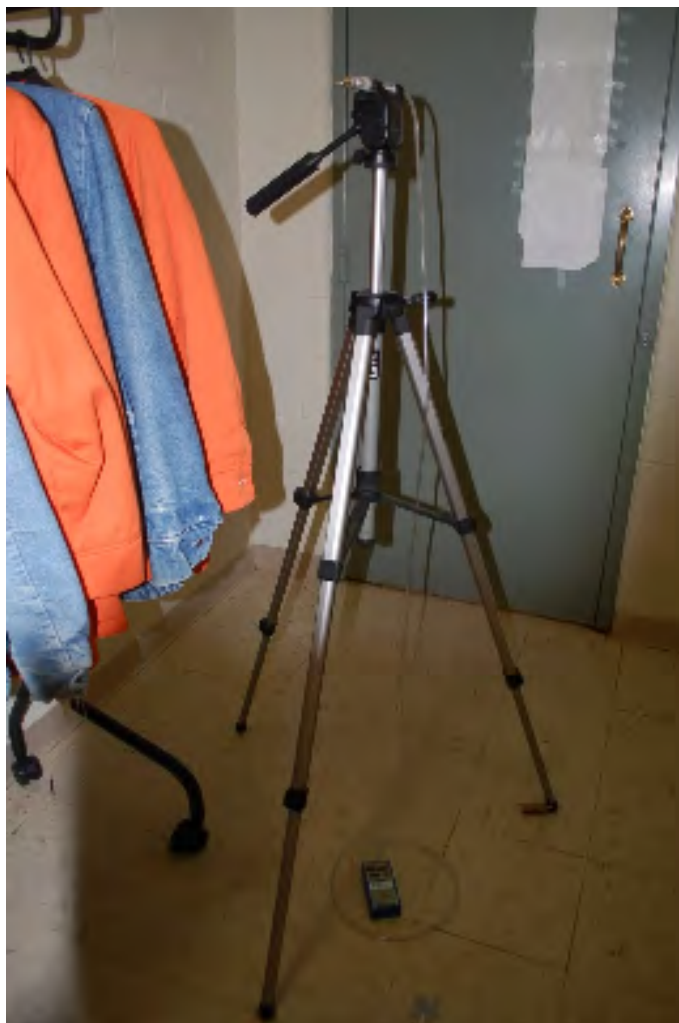
A-5. Collection of naphthalene sample at AA-4 (November 4, 2014).

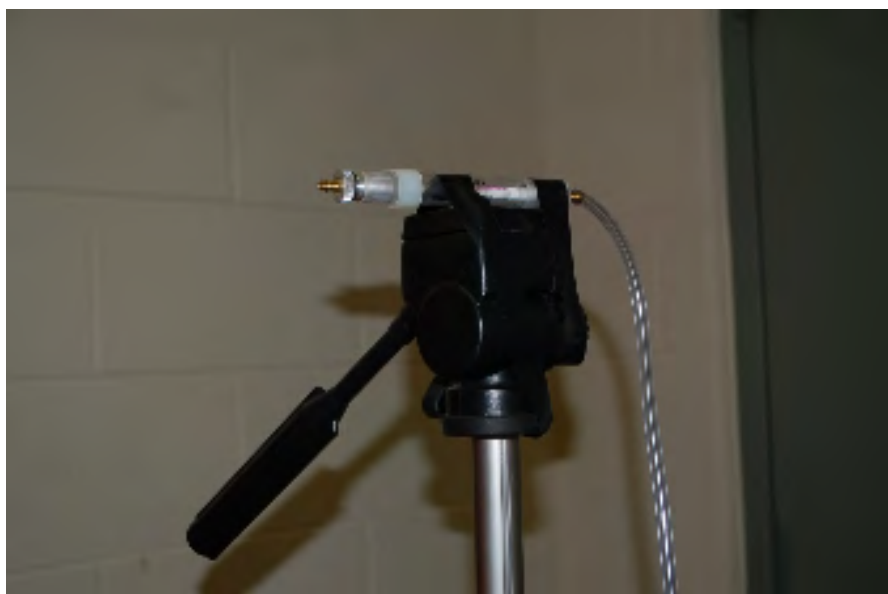
A-6. Close up of naphthalene tube in Gilian universal holder system (November 4, 2014).

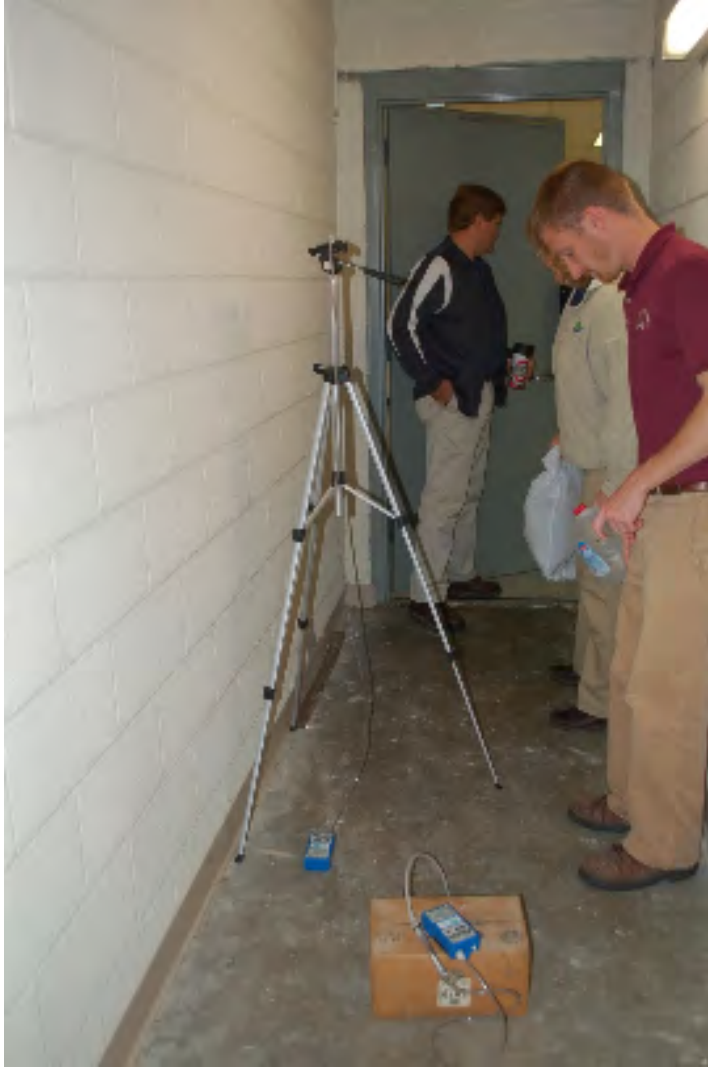
A-7. Co-located sub-slab and ambient air samples for naphthalene at SS-5 and AA-5 (November 4, 2014).

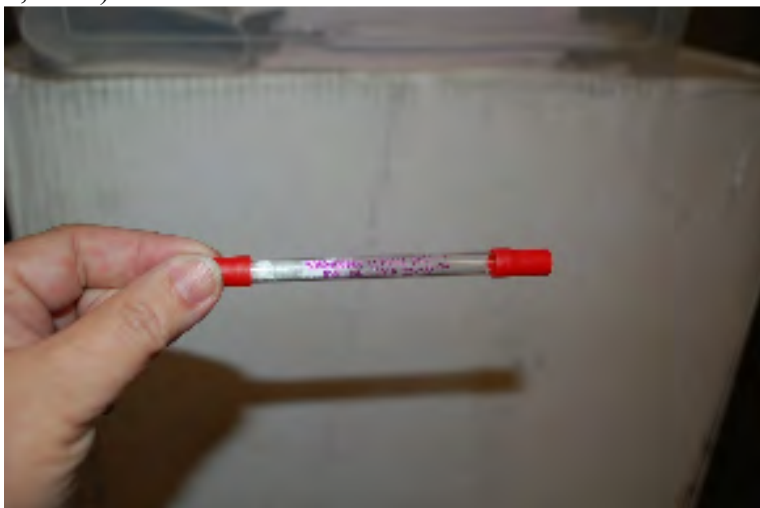
A-8. Naphthalene tube after sample collected with tight end caps prior to placing in plastic bag for labelling and shipping to laboratory (November 4, 2014).

After sample collection, tight-fitting caps were placed on both ends of the naphthalene tubes. One field blank was collected by breaking both ends of the naphthalene tube and placing caps on both ends. The capped tubes were placed in plastic bags that were labeled on the outside and sealed by pressing the plastic ridges together. The samples were placed on ice in a cooler with packing material to avoid damage and held overnight on ice. The samples were re-packed with fresh ice the next morning and taken back to the site. A chain-of-custody was prepared and the samples were delivered to the Test America Service Center in Columbus, Ohio on August 5, 2014. Test America repacked the samples and shipped them to Test America in West Sacramento, California for analysis.

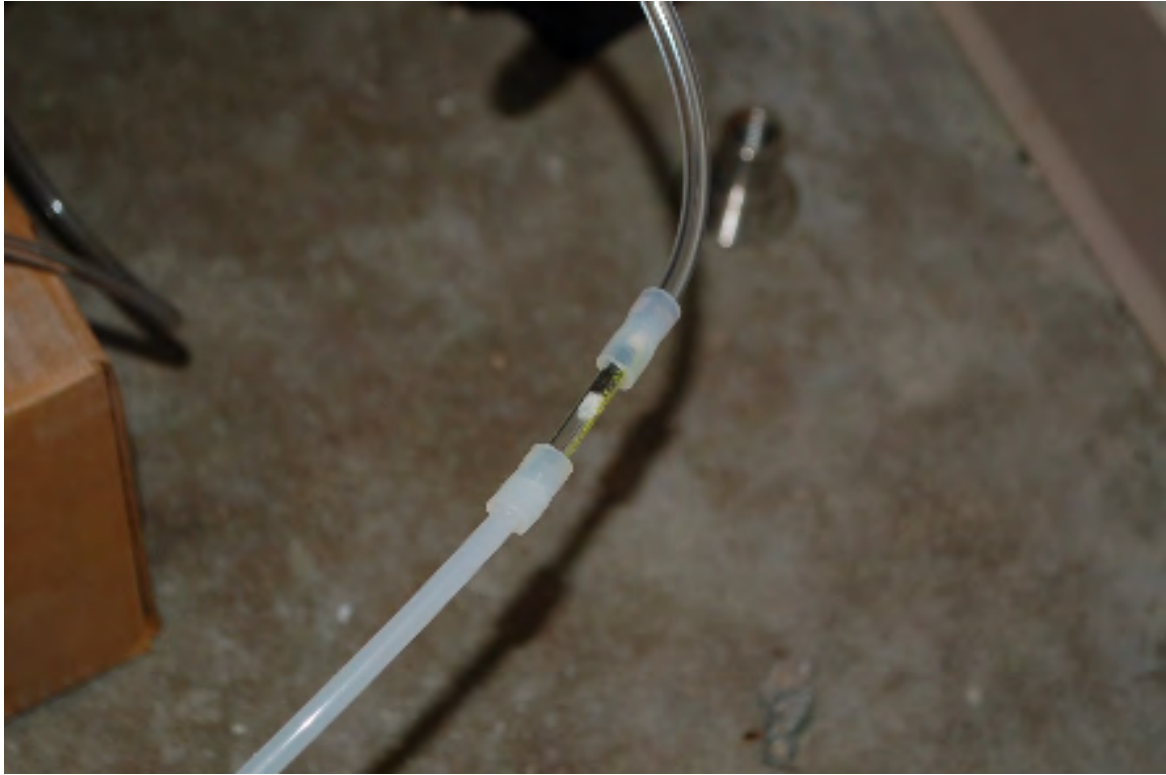
B-1. Close-up of mercury tube connected to sub-slab vapor pin (Teflon tubing) and Gilian Dual Mode Low Flow Sampler (Tygon tubing) with silicon sleeves (November 5, 2014).

Mercury samples were collected from all five sub-slab vapor monitoring points by placing a 3/8-inch silicon sleeve over the petcock barb and inserting a ¼-inch Teflon® tube into the silicon sleeve. The Teflon® tubing was inserted into a 3/8-inch silicon sleeve on the other end that was also placed over the inlet end of a glass mercury tube (Carulite, HYDRAR, Lot 8679, Exp. Aug/2018) from Test America after both ends were broken with a pair of needle nose pliers. Care was taken to make sure the flow arrow pointed toward the pump. Vinyl tubing (1/4-inch ID) was attached to the outlet end of the mercury tube using a 3/8-inch silicon sleeve. Samples were collected by pumping at a rate of 200 mL/min for 45 minutes, resulting in a total pumped air volume of 9 liters. Samples were monitored continuously during collection. Appendix B contains pictures of the collection of the mercury sub-slab vapor samples.

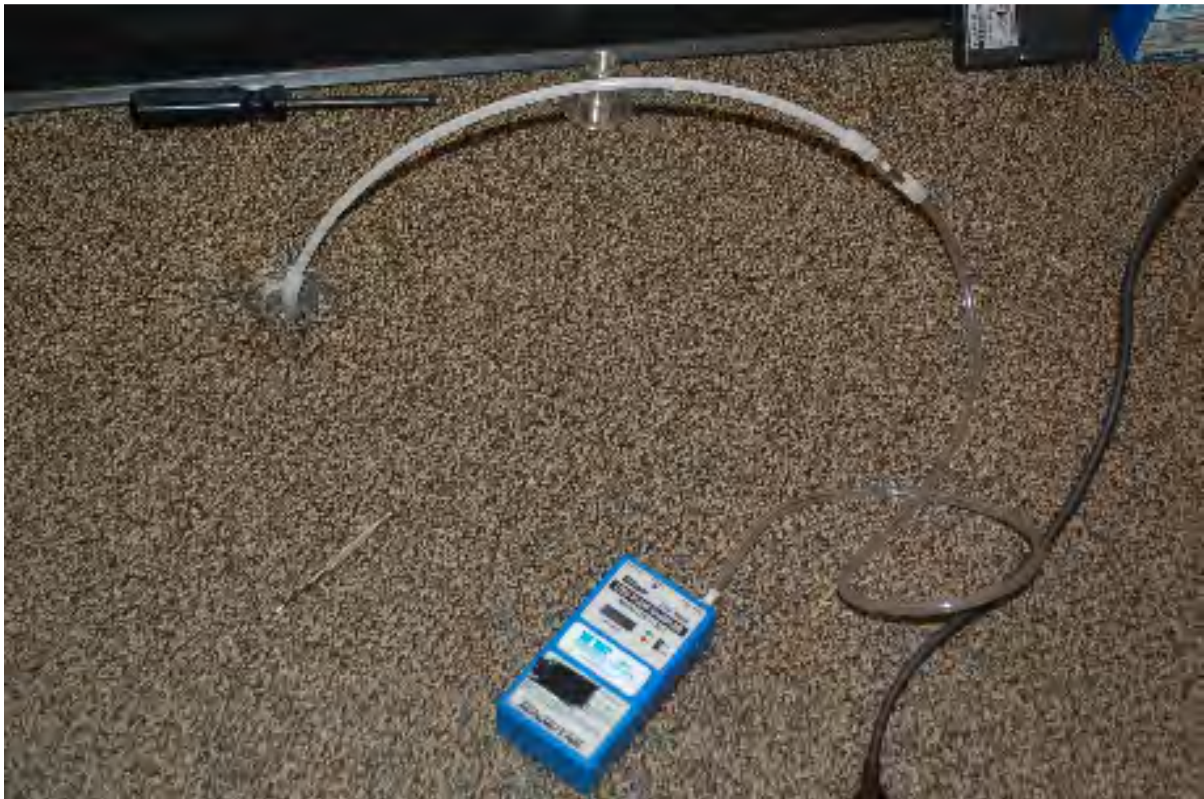
B-2. Sub-slab vapor pin sampling at SS-2 (November 5, 2014).

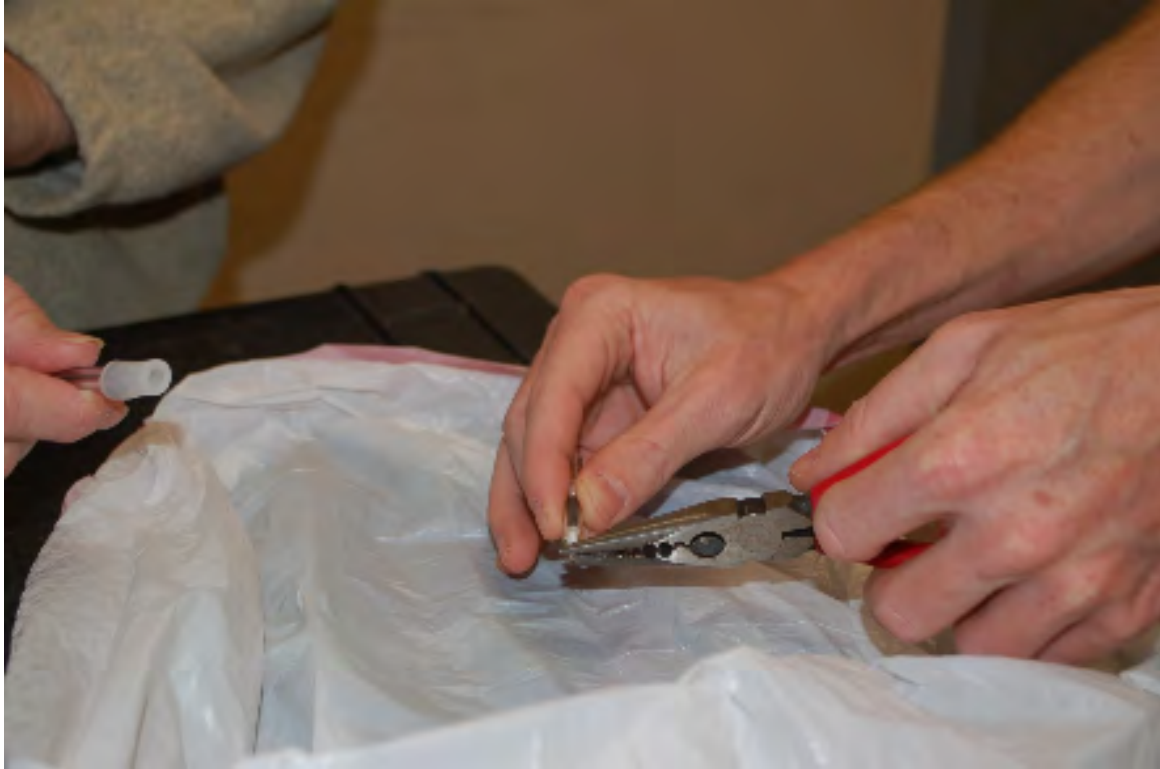
B-3. Breaking ends of mercury tube with needle nose pliers prior to sample collection (November 5, 2014).

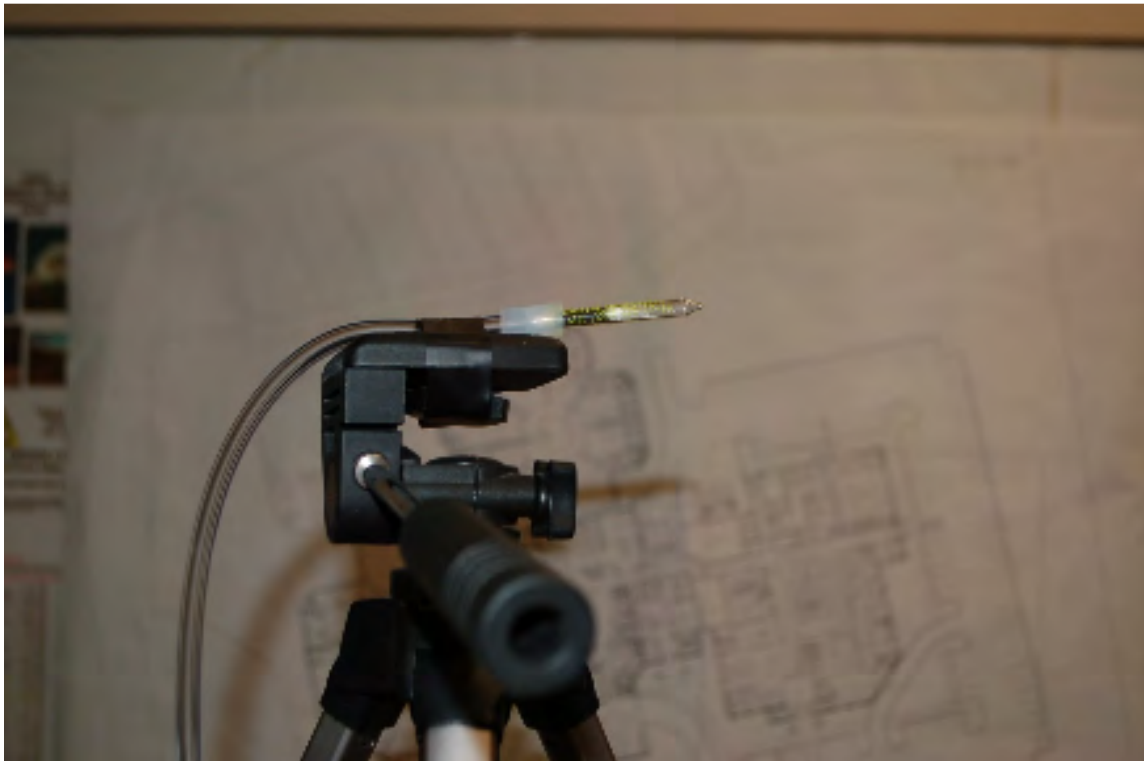
B-4. Close up of mercury tube on top of tripod during ambient air sampling at AA-2 (November 5, 2014).

Samples were collected by connecting the outlet end of a glass mercury tube to ¼-inch ID vinyl tubing with a 3/8-inch silicon sleeve. The vinyl tubing was then connected to the inlet of a Gilian Dual Mode Low Flow Sampler LFS-113DC. Both ends of the glass mercury tube (Carulite, HYDRAR, Lot 8679, Exp. Aug/2018) from Test America were broken with a pair of needle nose pliers before placing the mercury tube in the silicon sleeve with the flow arrow pointing toward the pump. The tubes were elevated to a representative breathing zone exposure height (Table 2) by attaching the tube to the top of an expandable tripod. Samples were collected by pumping at a rate of 200 mL/min for 480 minutes (8 hours), resulting in a total pumped air volume of 96 liters. Due to the long pumping time, the pumps were monitored at approximately intervals of 15 minutes (access permitting) to ensure that sampling was not interrupted by equipment failure or other problems. No problems were encountered during collection of the samples. Appendix B contains pictures of the collection of the mercury indoor ambient air samples.

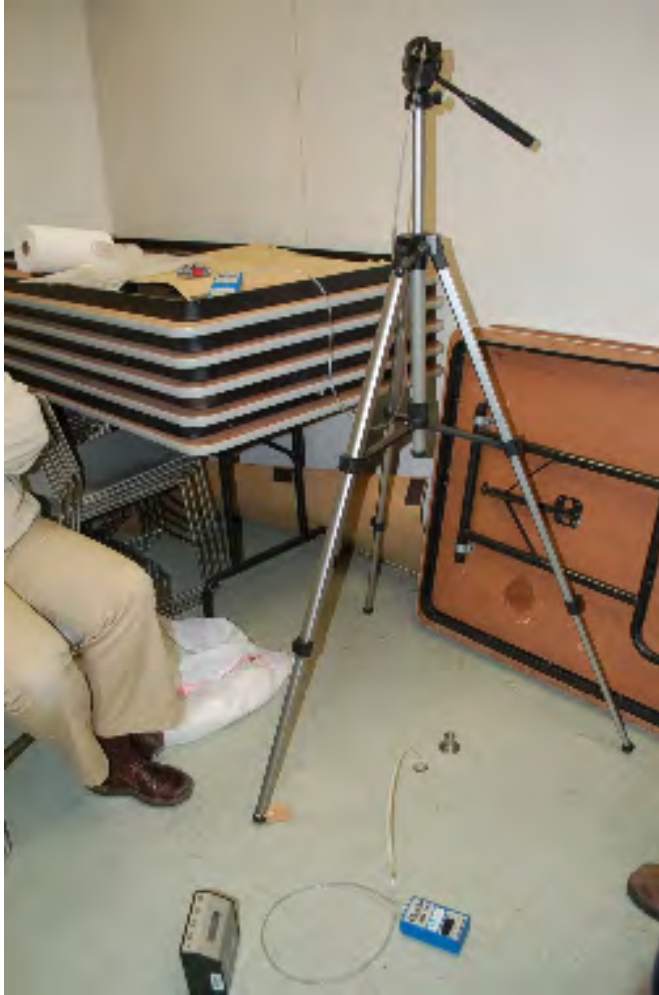
B-5. Co-located sub-slab and ambient air samples at AA-3/SS-3 (November 5, 2014).

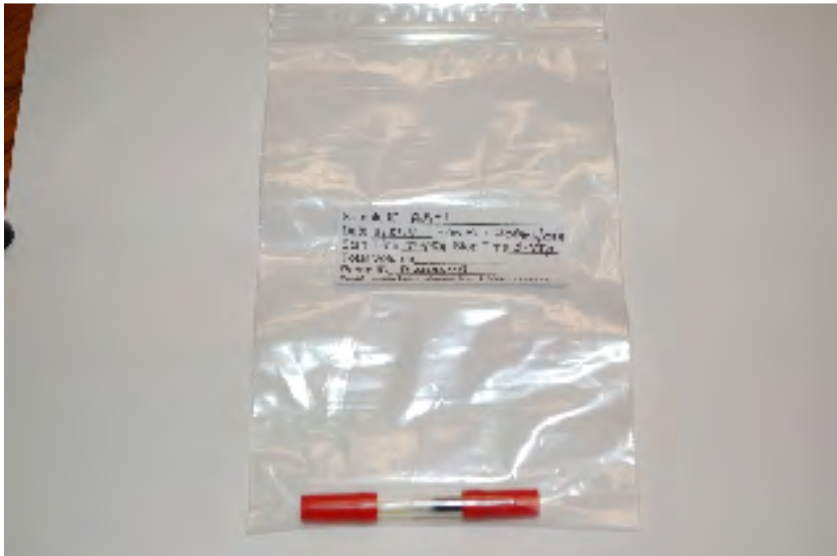
B-6. Mercury tube after sample collection with tight-fitting caps, placed in plastic bag and labelled for shipment to laboratory for analysis (November 5, 2014).

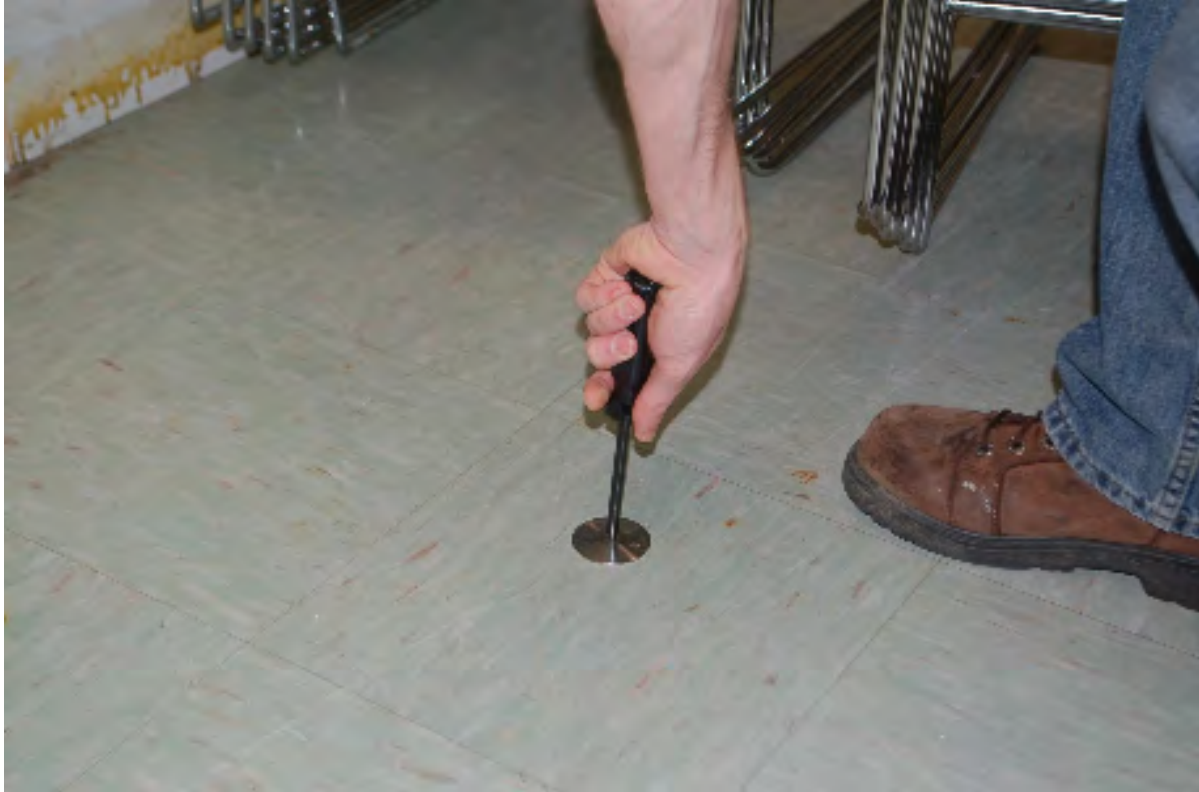
C-1. Removal of the cover plate for the sub-slab Vapor Pin™ assembly with the spanner tool.

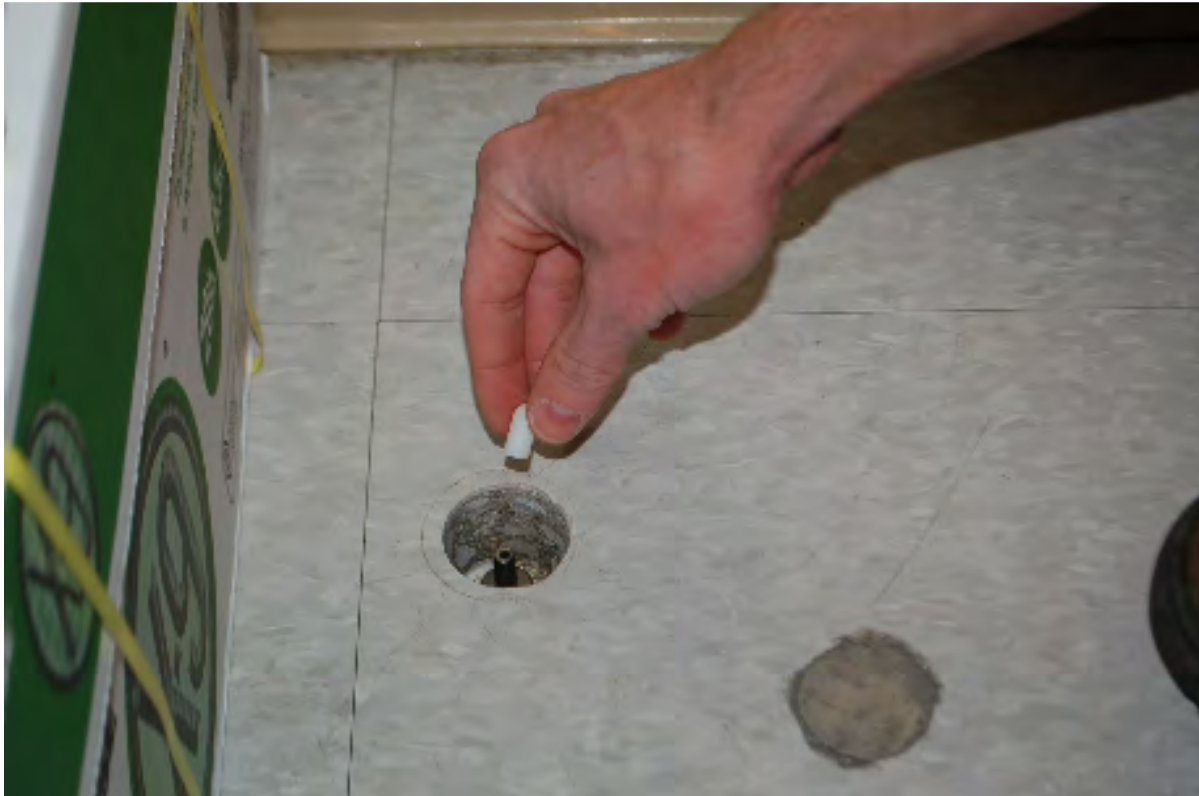
C-2. Removal of the cap from the sub-slab Vapor Pin™ assembly.

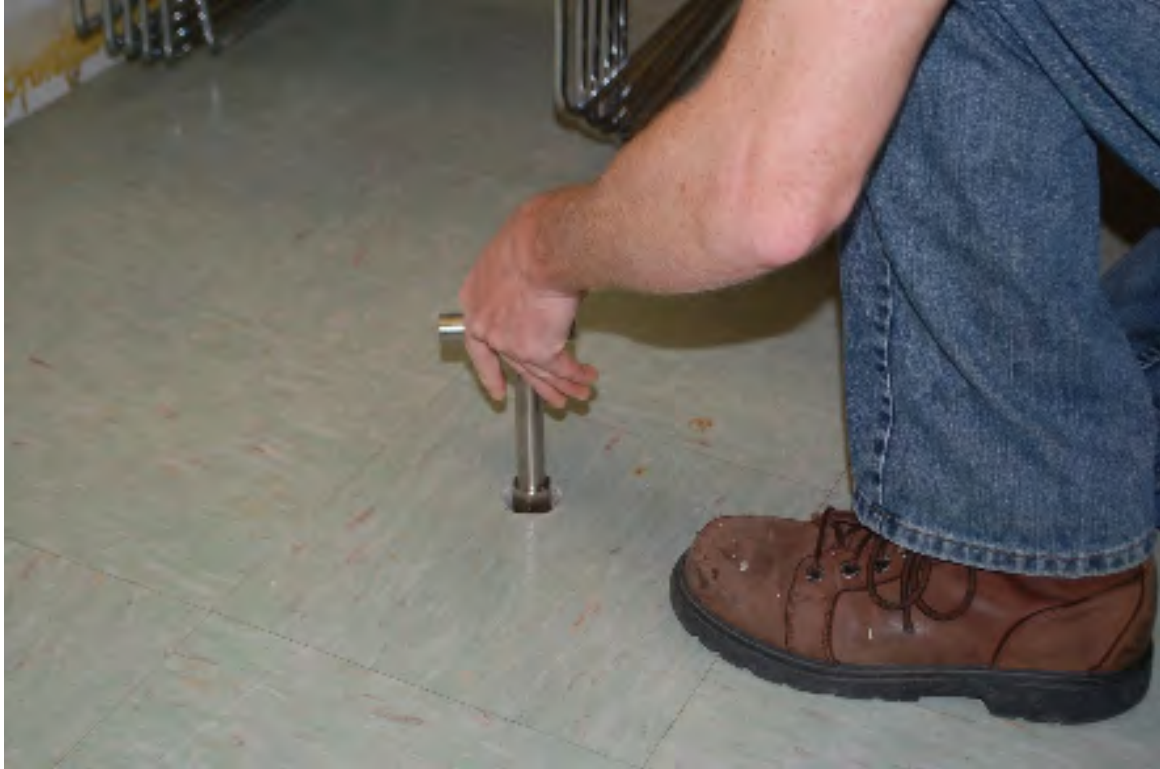
C-3. Using specialized tool to remove sub-slab Vapor Pin™ assembly.

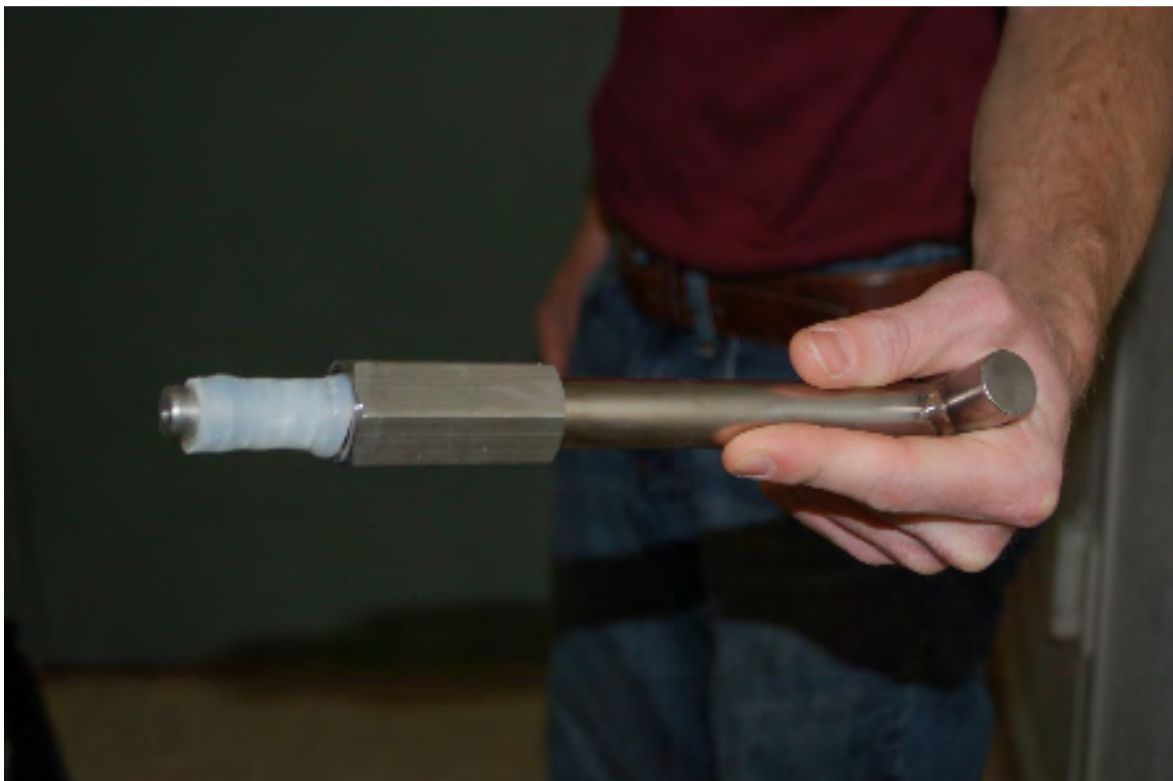
C-4. Sub-slab Vapor Pin™ assembly removed from the floor slab.

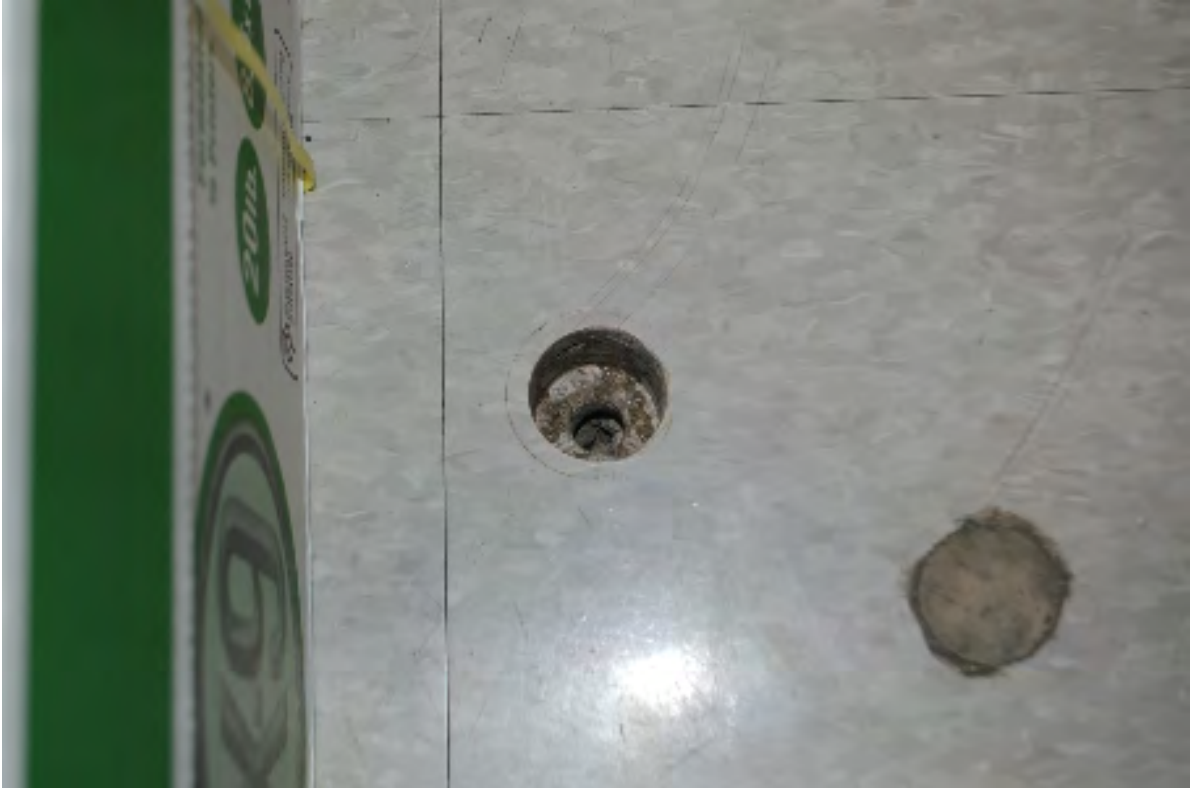
C-5. Hole in floor slab after removal of sub-slab Vapor Pin™ assembly.

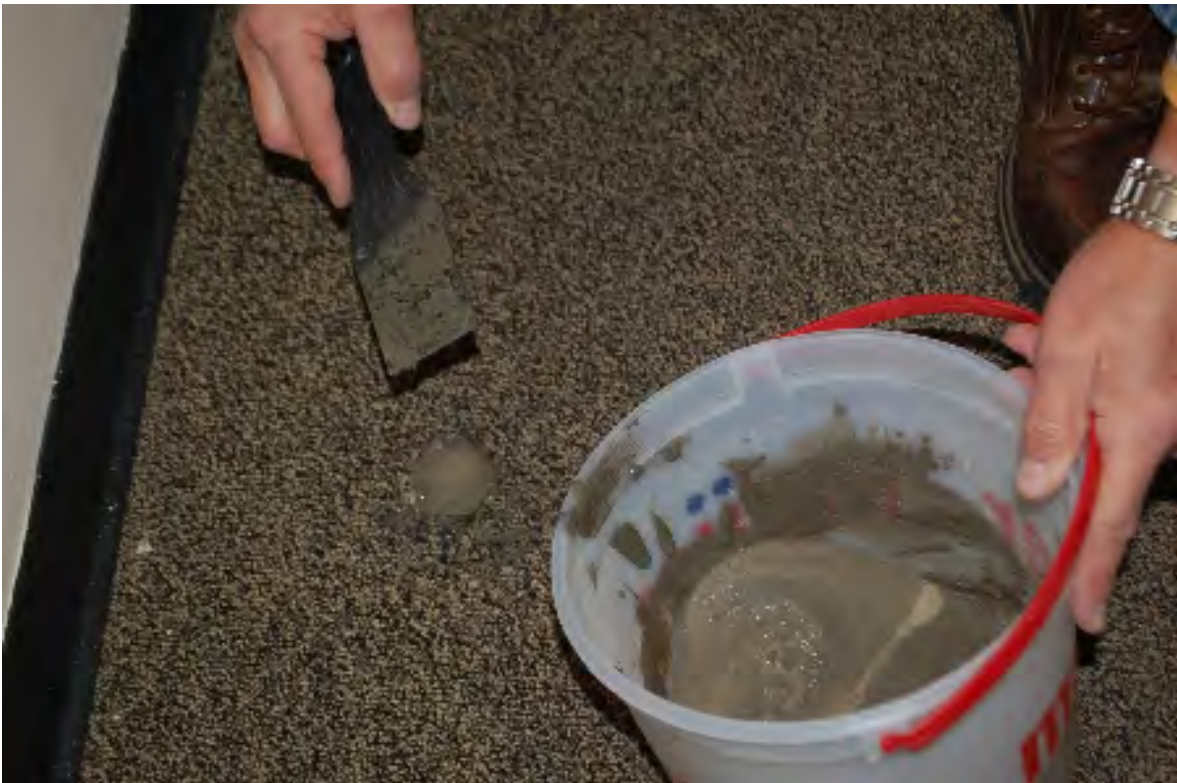
C-6. Filling hole in floor slab with patching cement.
