**Phase I Environmental Site Assessment
333 Lincoln Avenue,
Lancaster, Ohio
Volume 1 of 3 Report**

Submitted to:
Fairfield County
Board of Commissioners
210 East Main Street
Lancaster, Ohio 43130

Prepared by:
Bennett & Williams Environmental Consultants, Inc.
98 County Line Road West, Suite C
Westerville, Ohio 43082
(614) 882-9122

April 28, 2015

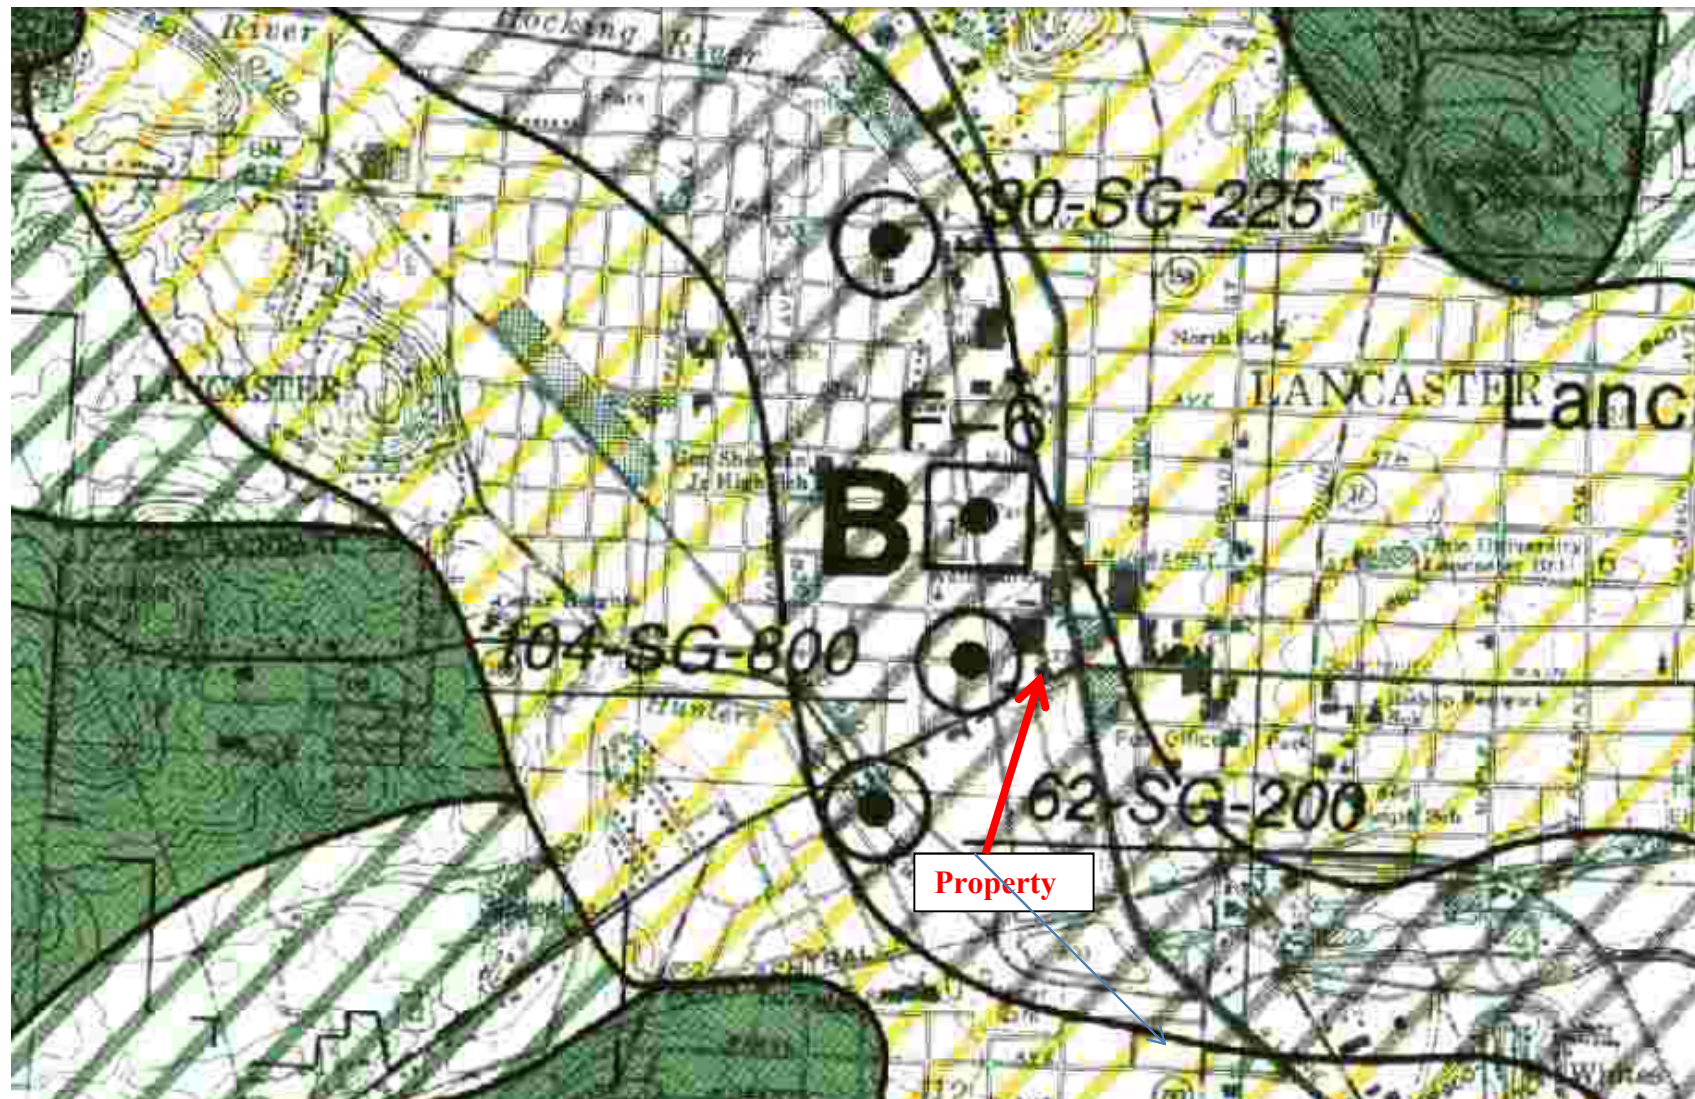
Figure 6. Bedrock contour map in the vicinity of the property (ODNR, 2013).

Indeed, the bedrock topography map (Figure 6) shows that the elevation of the bedrock underlying the site is at an elevation of approximately 700 feet amsl. Because the surface elevation of the site is approximately 825 feet amsl, the buried valley beneath the property (filled primarily with sand and gravel) is approximately 125 feet deep. Figure 6 shows that the bedrock becomes shallower to the east.

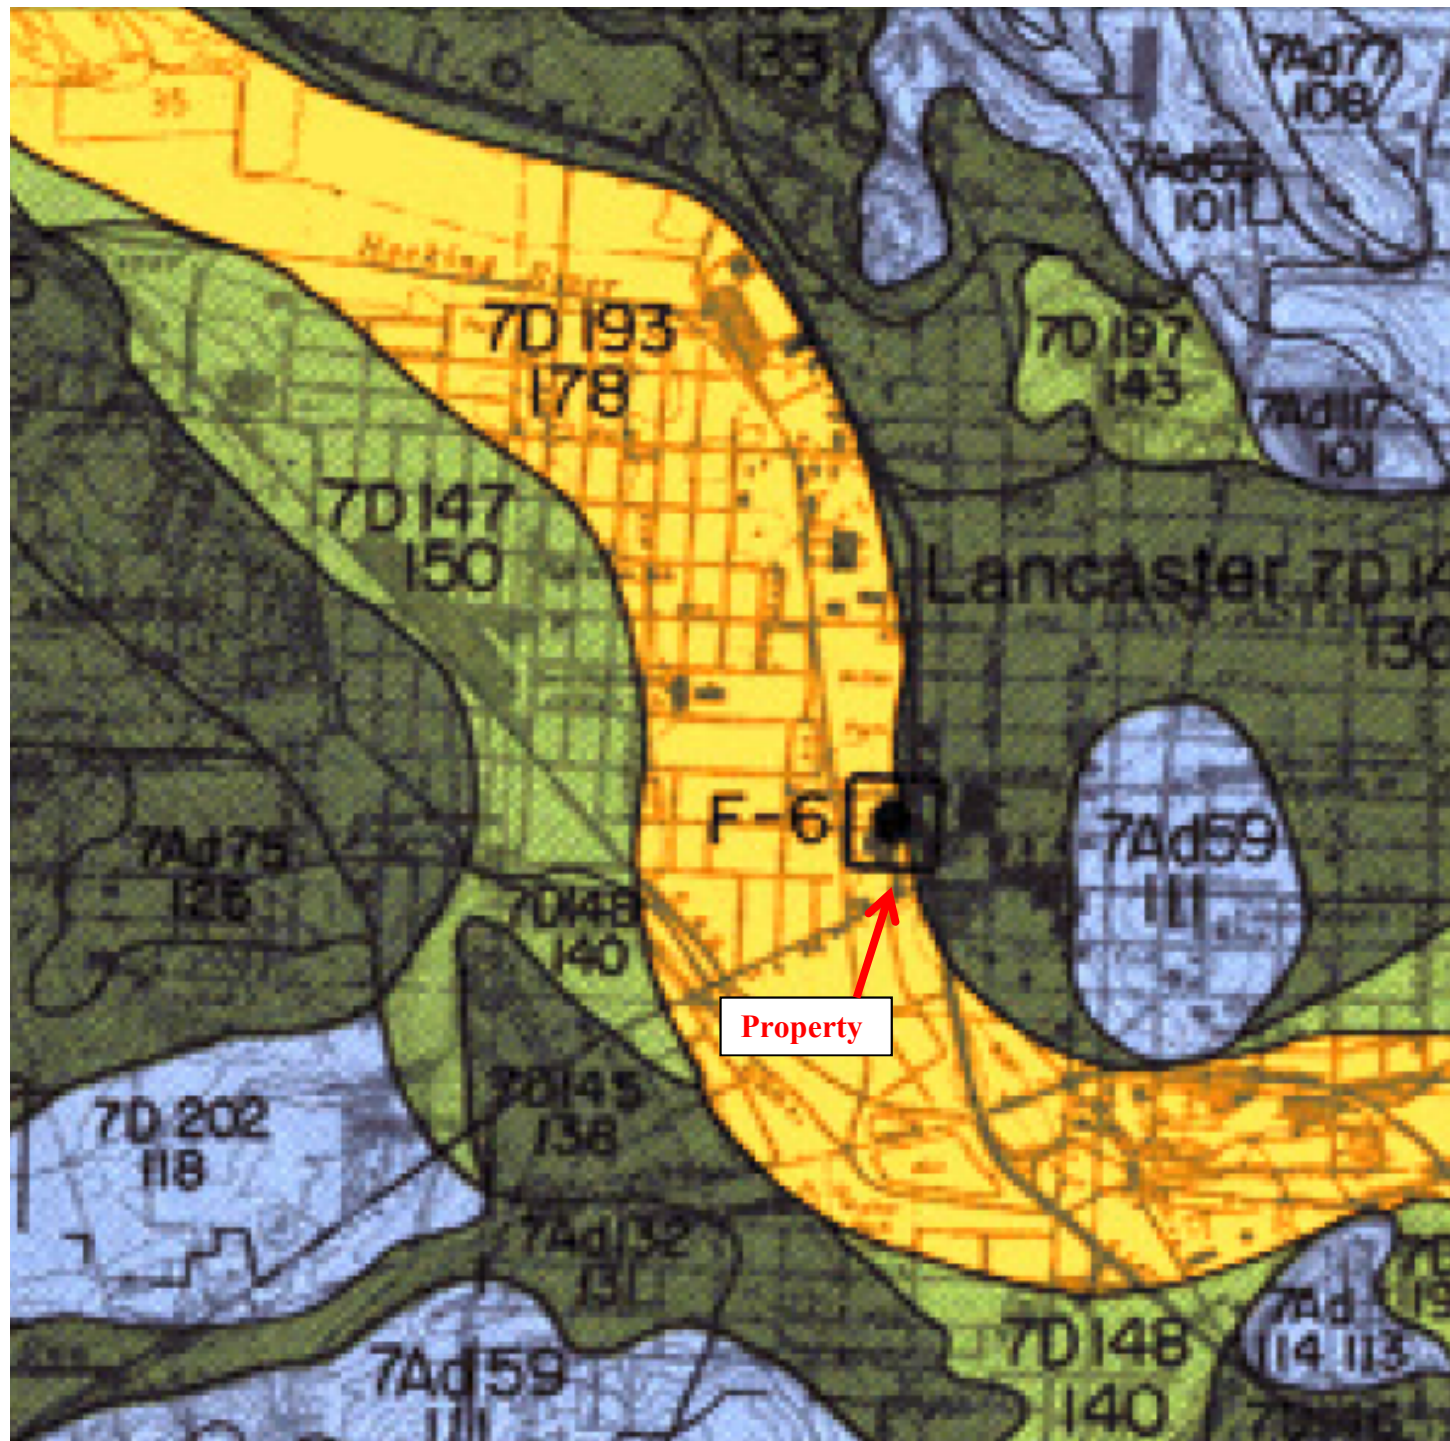
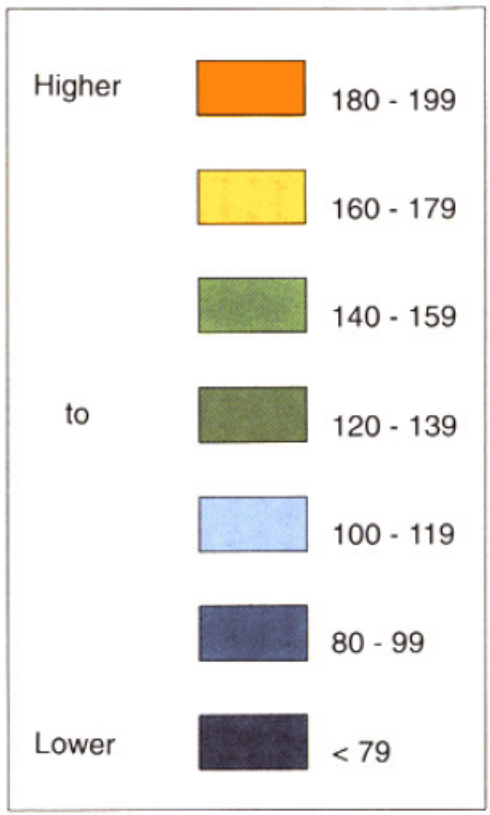
Figure 8. Groundwater pollution potential of area in the vicinity of the property (Schmidt, 1996).

- 6Da - Alternating Sandstone and Shale - Thin Soil
- 6Db - Alternating Sandstone and Shale - Thick Soil
- 7Aa - Glacial Till Over Bedded Sedimentary Rocks
- 7Ad - Glacial Till Over Sandstone
- 7Ae - Glacial Till Over Shale
- 7Af - Sand and Gravel Interbedded in Glacial Till
- 7D - Buried Valley
- 7Ec - Alluvium Over Bedded Sedimentary Rocks
- 7Ed - Alluvium Over Glacial Till
