Buckeye Lake Dam

Fairfield and Licking Counties, Ohio

REVIEW OF PAST REPORTS AND EXISTING CONDITIONS AND RECOMMENDATIONS FOR INTERIM RISK REDUCTION MEASURES, OPERATION, AND MAINTENANCE

March 2015

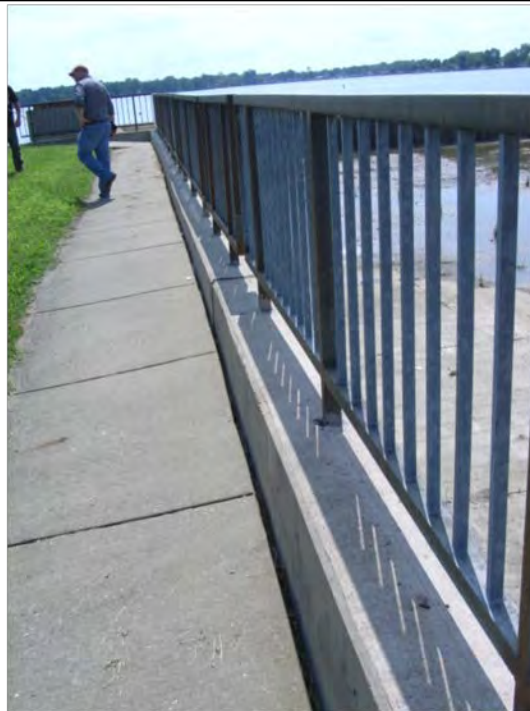
Photo 021 – View from west side of Sellers Point spillway. Note the large amount of eroded material deposited along the base of east training wall.

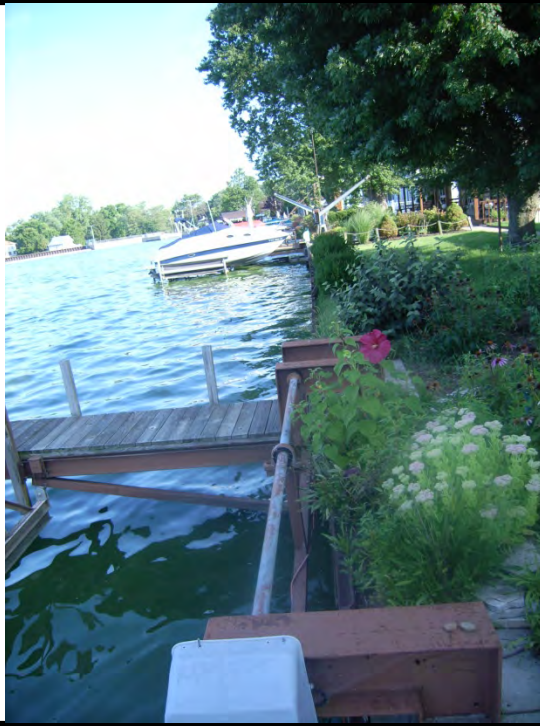
Photo 026 – Concrete masonry unit wall left from after a house was removed. Note redundant concrete walls most probably due to seepage related displacement and distress along upstream wall.

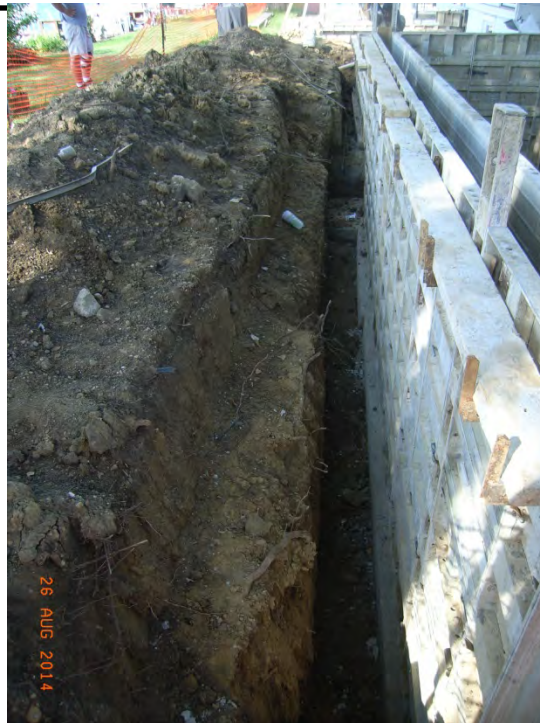
BUCKEYE LAKE 25 AUGUST 2014
Photo 044 – Unsupported excavation into embankment.
