March 18, 2014

ASSESSMENT OF THE  
**CLARENCE E. MILLER BUILDING**

1587 Granville Pike, Lancaster, Ohio

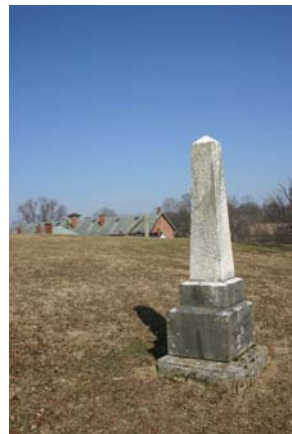
The facility was originally the County Infirmary as well as a County Home for the poor and elderly. As a result, sometime in those early years, a graveyard known as the "Pauper's Cemetery" came into being further up the hill directly west of CEM. The inscription on the cemetery marker still standing in the middle of the cemetery (shown at right) states "To the Memory of Our Dead" and is dated 1886.

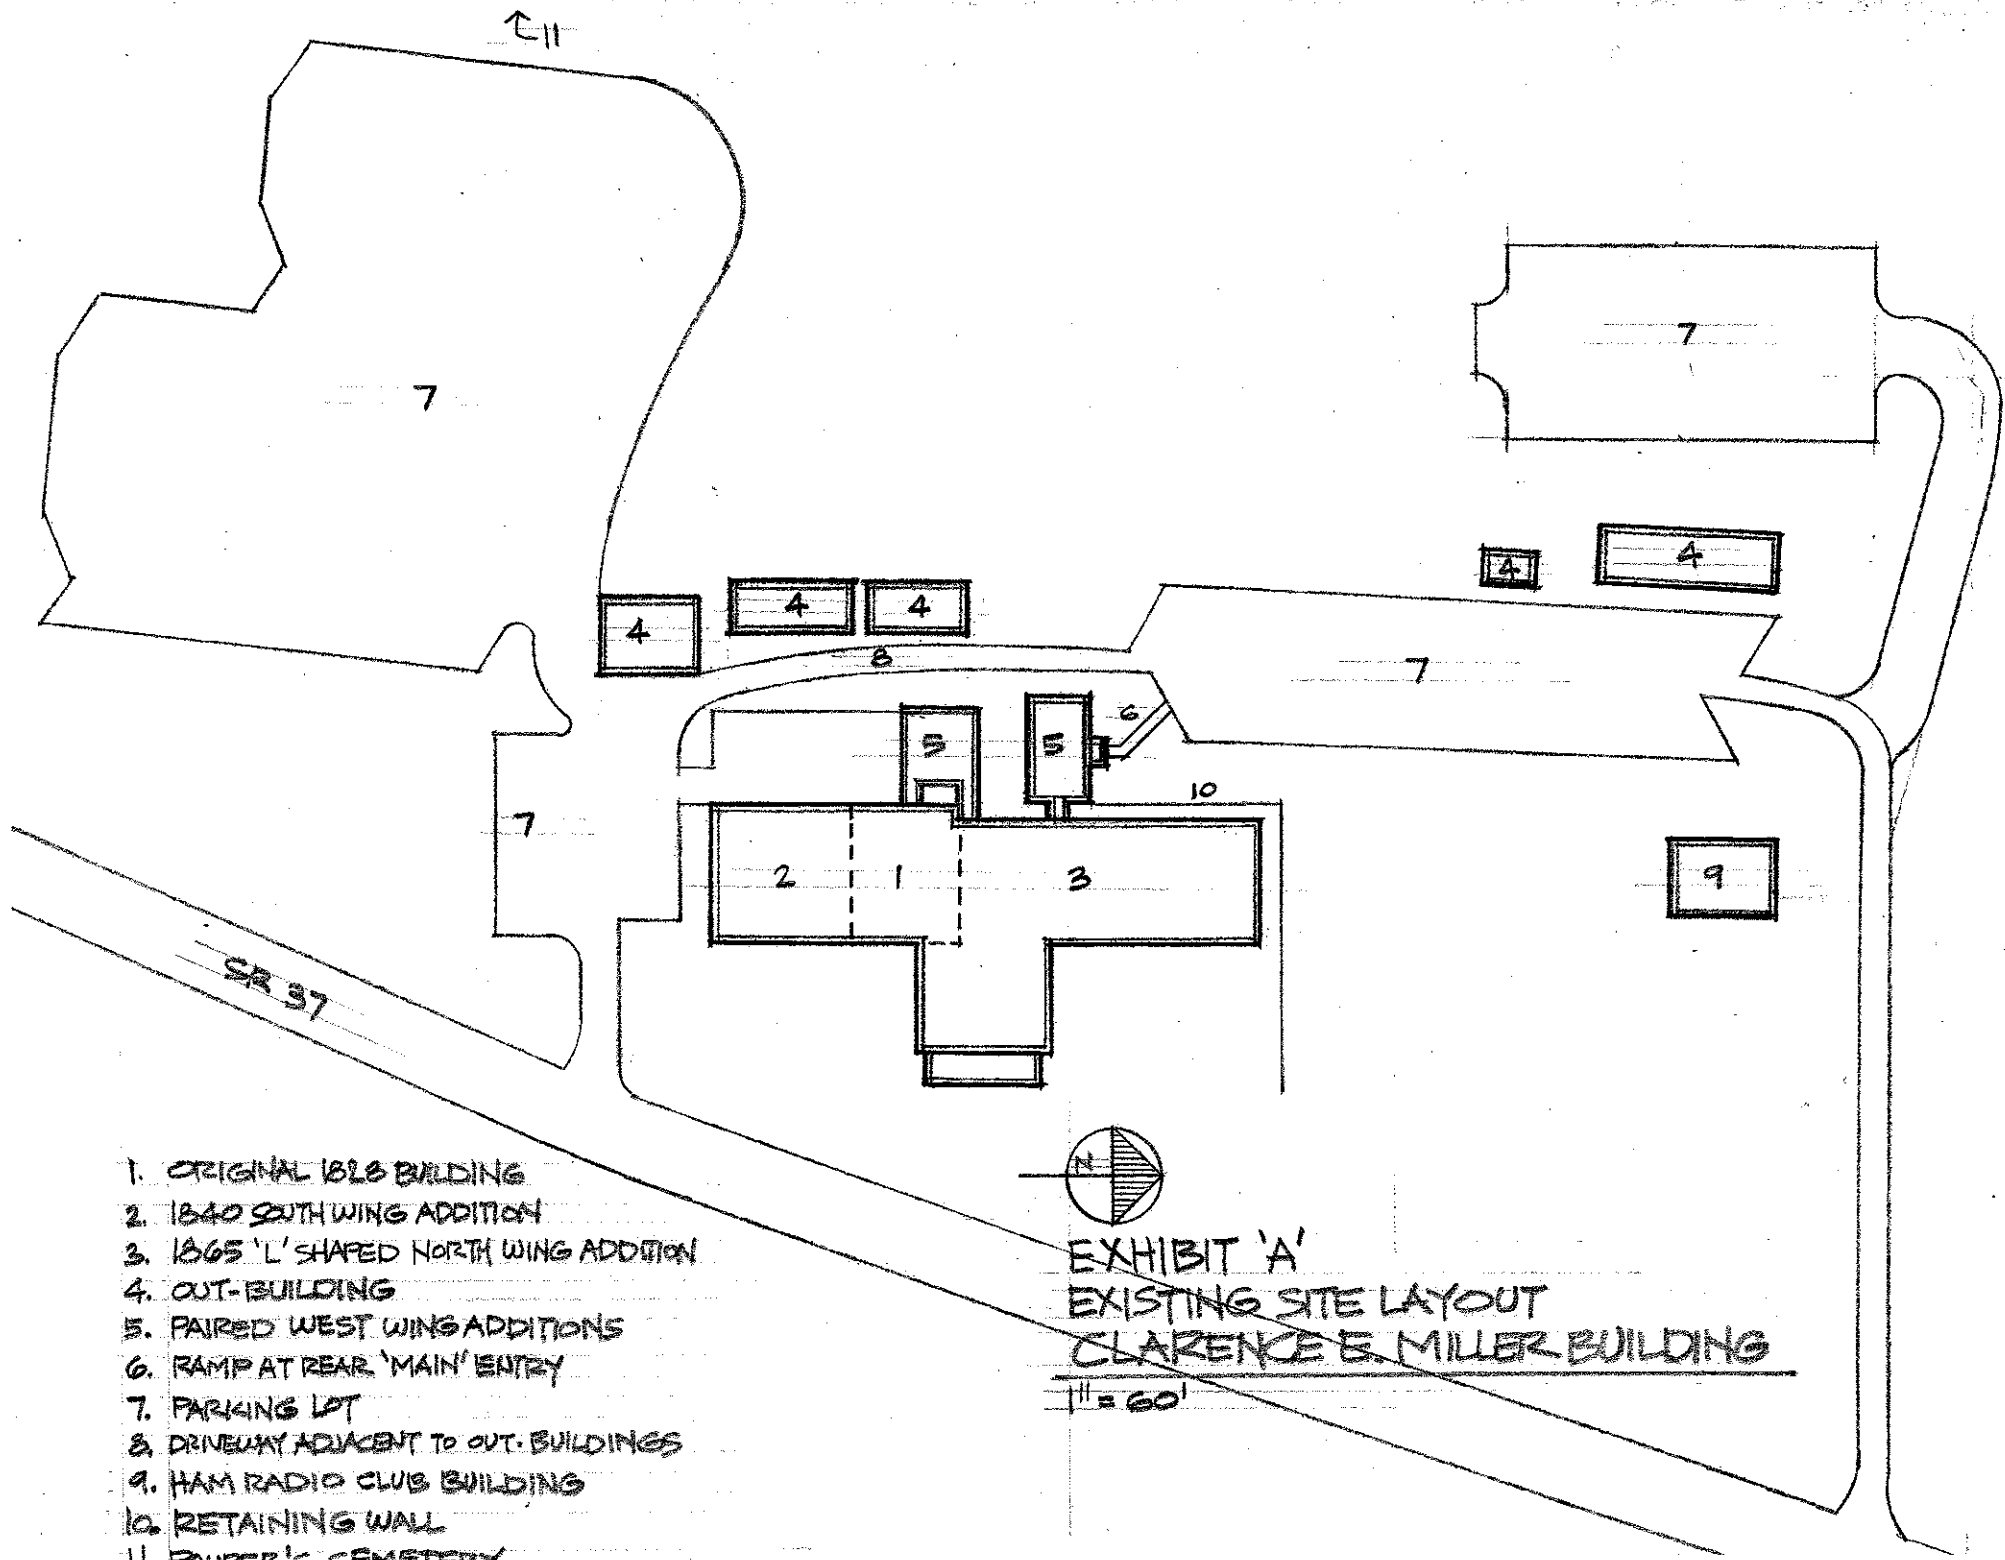
EXHIBIT 'A'  
 EXISTING SITE LAYOUT  
 CLARENCE E. MILLER BUILDING

1. ORIGINAL 1828 BUILDING
2. 1840 SOUTHWING ADDITION
3. 1865 'L' SHAPED NORTH WING ADDITION
4. OUT-BUILDING
5. PAIRED WEST WING ADDITIONS
6. RAMP AT REAR 'MAIN' ENTRY
7. PARKING LOT
8. DRIVEWAY ADJACENT TO OUT-BUILDINGS
9. HAM RADIO CLUB BUILDING
10. RETAINING WALL
11. FAUPER'S CEMETERY

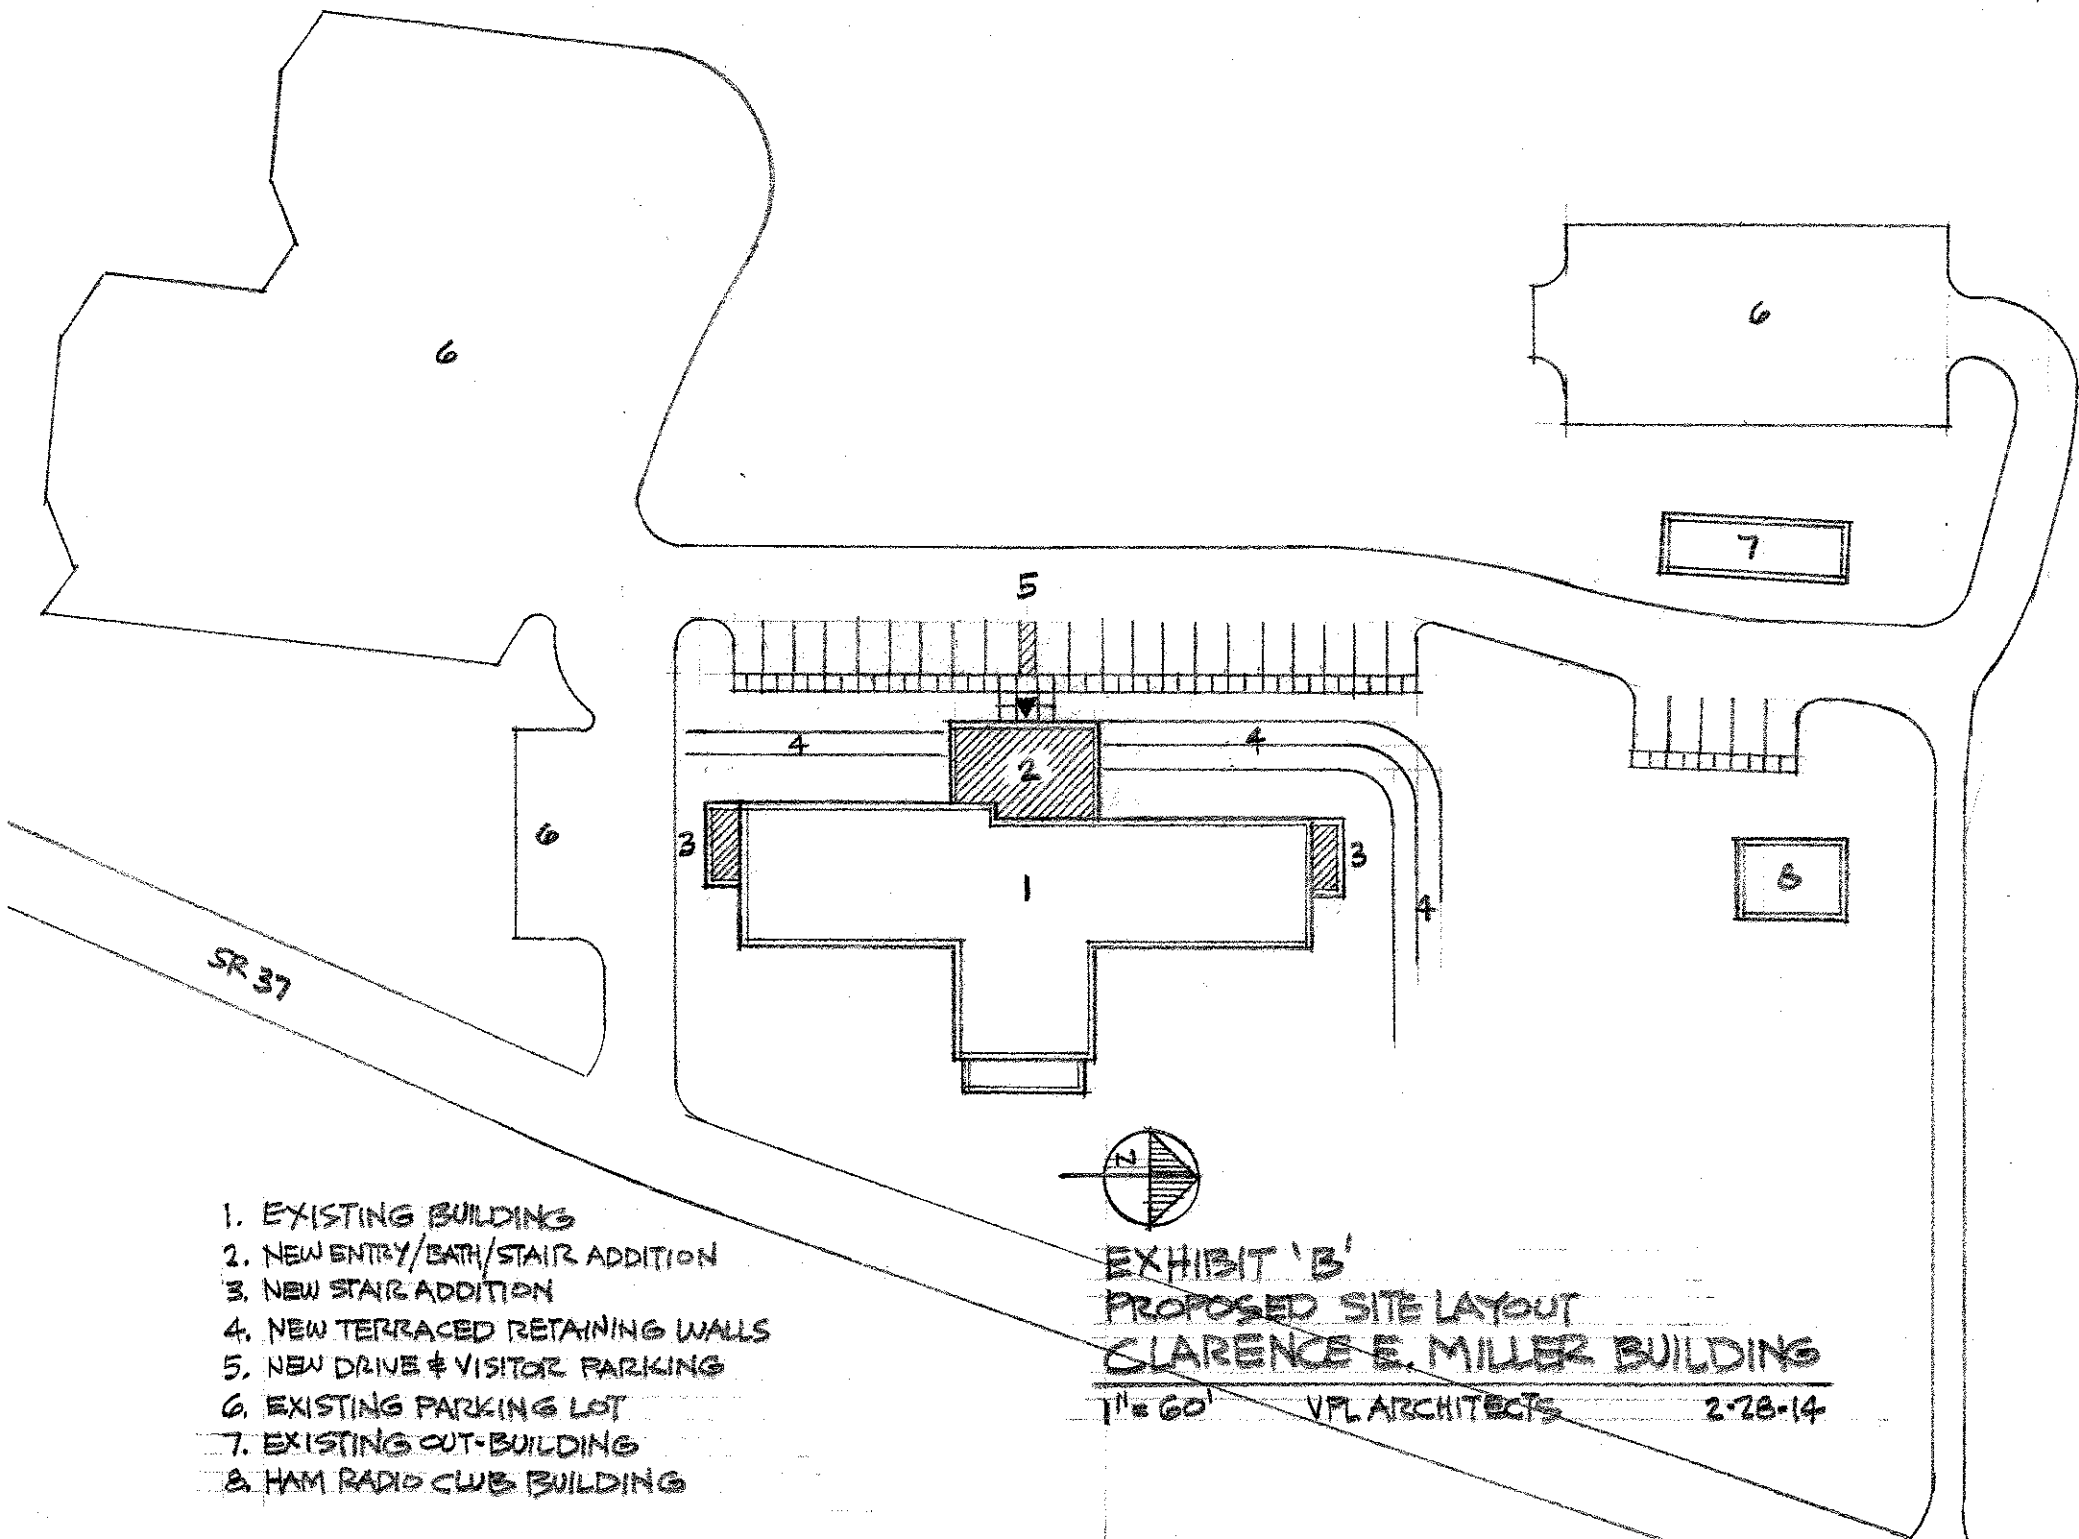
EXHIBIT 'B'  
 PROPOSED SITE LAYOUT  
 CLARENCE E. MILLER BUILDING

1. EXISTING BUILDING
2. NEW ENTRY/BATH/STAIR ADDITION
3. NEW STAIR ADDITION
4. NEW TERRACED RETAINING WALLS
5. NEW DRIVE & VISITOR PARKING
6. EXISTING PARKING LOT
7. EXISTING OUT-BUILDING
8. HAM RADIO CLUB BUILDING
